Reconciling Foreshore Development and Dune Erosion on Three Queensland Beaches: An Historical Perspective

MIKE DANAHER

ABSTRACT

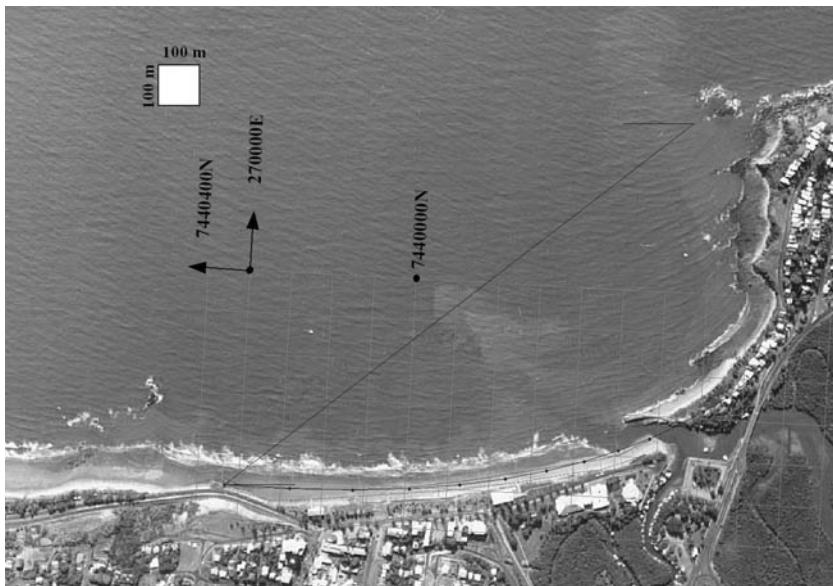
FIGURE 2. Aerial view of Yeppoon Main beach, c. 1999. Source: Piorewicz, 2004b.

Yeppoon Main beach is north south aligned between Spring Head and the bluff in the north, and Ross Creek outlet in the south (see Figure 2). Photographs from c. 1910 show an undeveloped, well-established dune system (see Figure 3). First impact was caused by access tracks across the dunes to the beach by campers who had travelled down to the coast in order to escape very hot conditions further inland and invigorate their health. Photographs from c. 1920 show an increase in tracks, some widening to sand blows.¹ The area behind the dunes was low-lying and therefore conducive to sand blows.

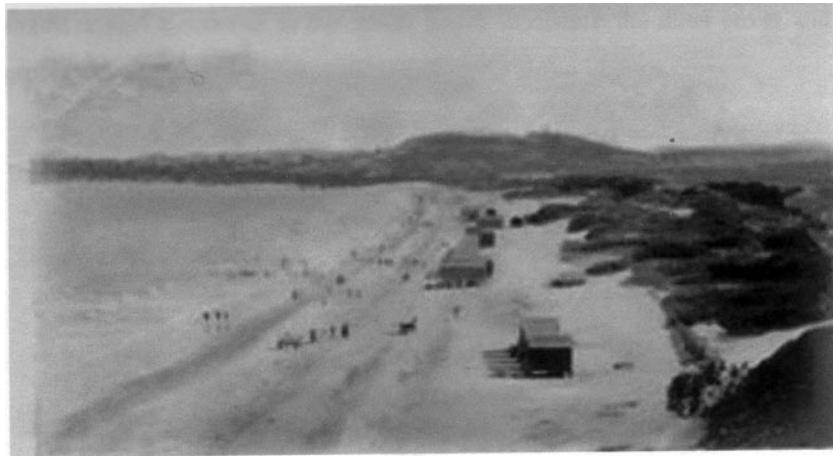
FIGURE 3. Well developed dune systems evident on Yeppoon Main beach, 1920s. Source: Capricornia Collection, Central Queensland University.

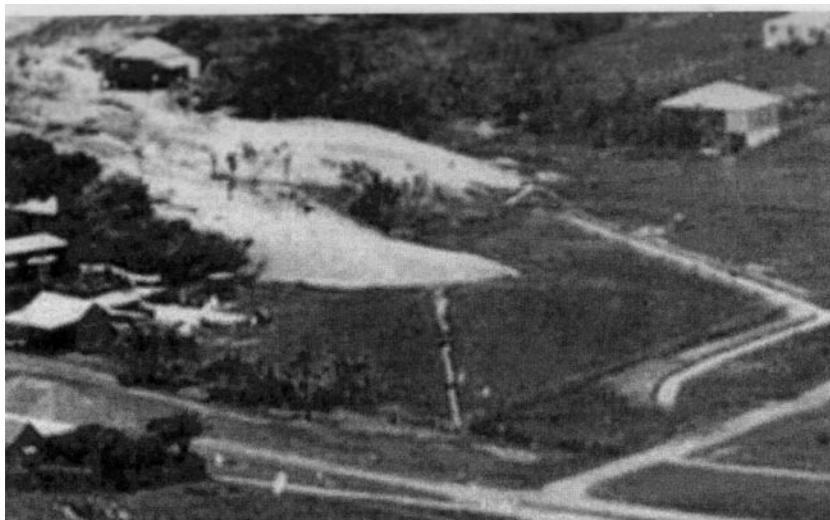
FIGURE 4. Sand drifting a long way into Yeppoon township, c. 1910. Source: Capricornia Collection, Central Queensland University.

photographs show how the sand drifted inland a considerable way, reaching at least to where the buildings along the esplanade are today and, in places, occasionally stretched almost the length of the town block (about 100 metres – see Figure 4). Rough tracks and pathways from town streets across the dunes

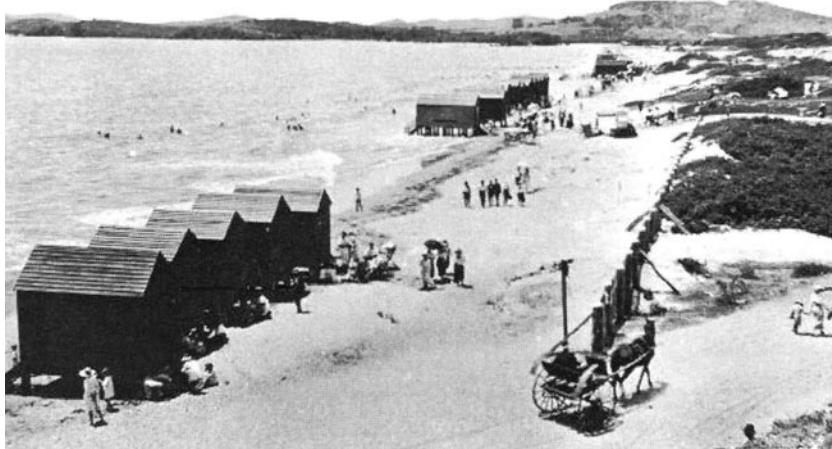
FIGURE 6. Timber fence and changing sheds on Yeppoon Main beach c1930. Source: Capricornia Collection, Central Queensland University.

During the early 1920s a timber post and netting protection fence was built along the northern part of the beach, 'probably with the purpose of preventing sand blowing onto the nearest road' (see Figure 6). These sand drifts would have been a nuisance to the town's residents and authorities. Sand shifted across roads, accumulated in a popular beachfront park and damned drains causing minor flooding during rain. For the next fifty years managing encroaching sand, not beach erosion, was a principle occupation of the shire road gangs. The beach was also used as a roadway by sulkies, bicycles and motorcars until in 1923 the Livingstone Shire Council (LSC) prohibited any vehicles from using it. In the late 1920s a track was pushed along the crest of the dunes and later became known as Anzac Parade (see Figure 7). It was bituminised in 1936. The LSC permitted the removal of large quantities of sand from behind the foreshore for this road and parking spaces. Recreational infrastructure was built on the main beach (at high water mark) from about the 1910s to 1930s as part of establishing the seaside holiday resort atmosphere of Yeppoon, and some of this infrastructure necessitated more sand being removed from the dunes. Mullins⁴ writes:

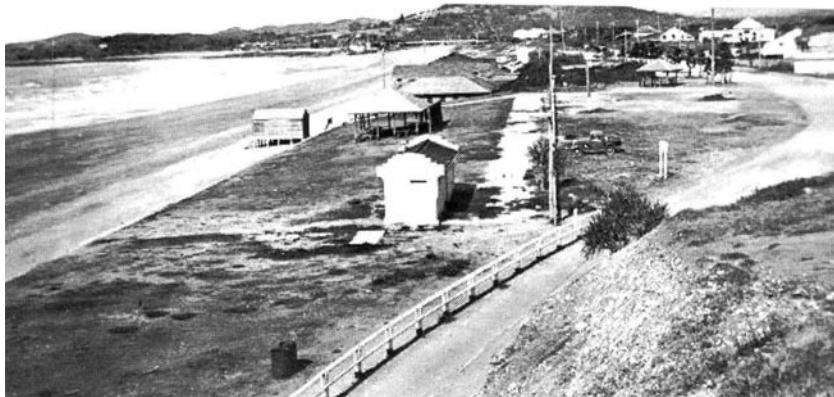
FIGURE 8. Vertical sea wall and levelled grassed area, 1938. Source: Capricornia Collection, Central Queensland University.

Between 1935-38 a stone retaining sea wall was built and the dunes levelled as part of the ‘foreshore improvement scheme’. This was done for various reasons. For example, it was partly ‘to provide, it is thought, better access to the beach and a grassed area for picnicking’. The wall was also constructed to stop dwellings, which were built within the natural buffer zone between the beach and back dunes, from washing away.⁵ The wall helped to provide a solid foundation for the development of a new recreational area. Furthermore, the LSC may only have decided to proceed with the work because of the ready availability of unemployment relief funding from other levels of government during the depression.⁶ At the official launch of the scheme, Shire Chairman William Todd said ‘the unsightly sand dunes that continue from the main street to Ross Creek will be done away with and in their stead there will be green lawns, seats, shade trees and plenty of parking places for cars’.⁷ However, the wall also prevented natural dune erosion and replacement.

The sea wall was built in front of the dunes, below the spring tide line, running 150m south from the bluff. After the dunes were levelled the area was grassed⁸ (see Figure 8). It is hard to imagine that the Main beach dunes would not have been destroyed considering their location directly in front of a growing town at a time when access to other beaches was difficult and understanding of dune systems was not as advanced as it is today. The sand blows did not help their protection either. Chairman Todd’s attitude was indicative for the times. The provision of facilities for visitors and the protection of structures on the beach, on Anzac Parade and the road around the Bluff, which represented large investments by business and the LSC, were the limits of beach management. The preference for levelled grassed surfaces over undulating sand surfaces has been a continued feature of LSC public works, appearing in Council minutes as late as 1973.⁹ Even though there might have been individuals around in the 1920s and 30s who worried about detrimental future impacts of these infrastructure decisions on natural systems¹⁰, apart from lobby groups campaigning for more national parks, healthier cities and attempting to protect native animals from traders, it was not yet the era for community conservation groups to form and challenge the authorities about impacts on dune systems. In fact, at the time engineering feats were generally and widely praised.¹¹ Future generations of Yeppoon residents have probably grown up not realising that sand dunes were once an extensive part of the Main beach and are therefore not aware of their loss.

Early photographs showing the original dune alignment indicate the wall was constructed about 20 metres forward of the dune scarp, and the dunes levelled and pushed forward against it. This indicates that the wall was built in an active beach zone, coinciding with high water mark.¹² Therefore, there is almost no usable beach available at most high tides (see Figures 10 and 11). Furthermore, the LSC noted that the constructors had to cope with the sea filling the excavations for laying the foundation stones of the sea wall.¹³

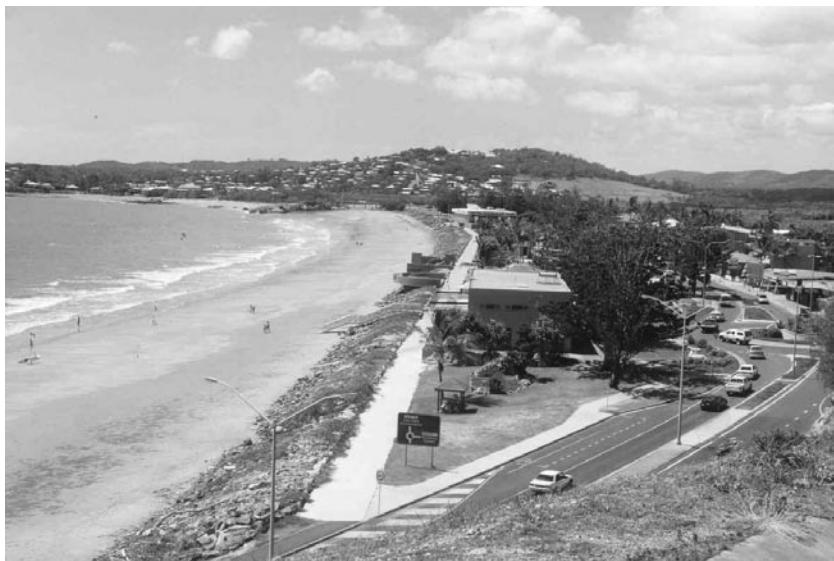
FIGURE 9. Same view as Figure 8 but in 2003 (road has been widened). Source: Photo taken by Mike Danaher, December 2003.

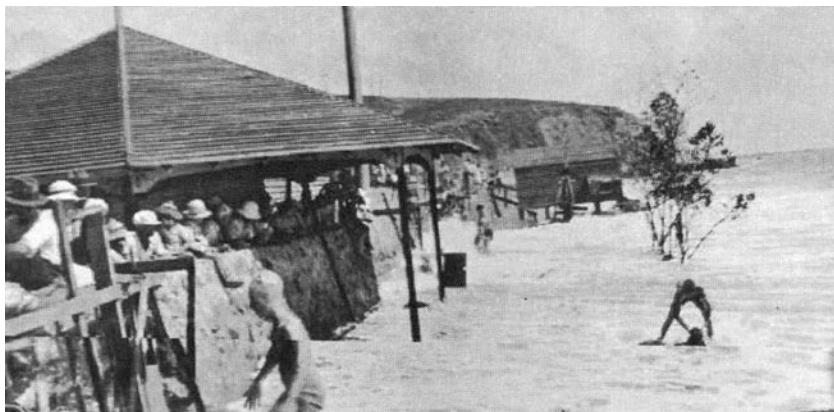
FIGURE 10. Sea wall built just below high tide mark, 1930s. Source: Capricornia Collection, Central Queensland University

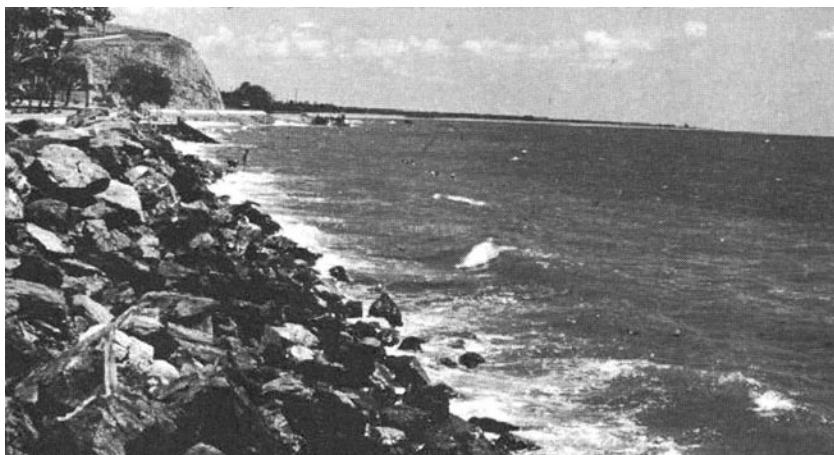
.FIGURE 11. High tide on Yeppoon Main beach with no beach available, 1990. Source: Piorewicz, 2002: 85.

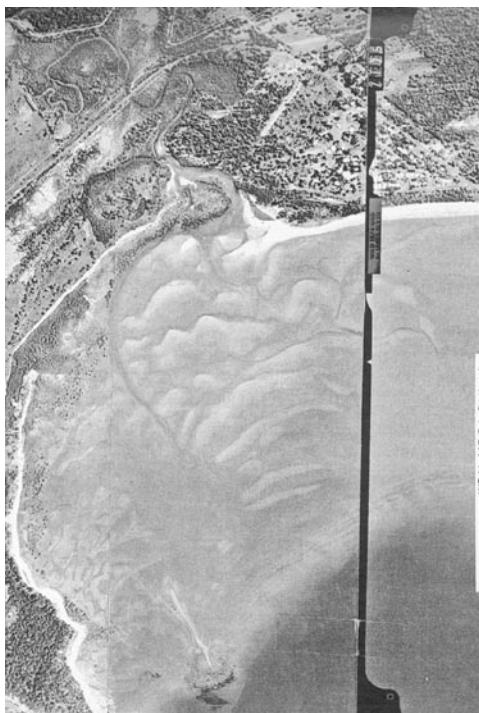
FIGURE 12. Aerial view of Kinka beach showing southward moving channel, 1988.

Despite the engineers of the time ‘carefully planning and considering’ tidal flow and the more intense velocity of flow-through seawater due to a significant narrowing of the creek mouth, the construction of the bridge and causeway was instrumental in delayed dune erosion along Kinka beach to the immediate south. The resultant restricted tidal prism from the lake reduced the width of the original channel across the beach, changed its original path to a southward moving path by the 1950s, and created a sizable sand bar at the mouth of the inlet to the lake (see Figure 12).⁴⁶ The hydrographical and morphological consequences of changes caused by constructions such as causeways were largely unknown at the construction stage.⁴⁷

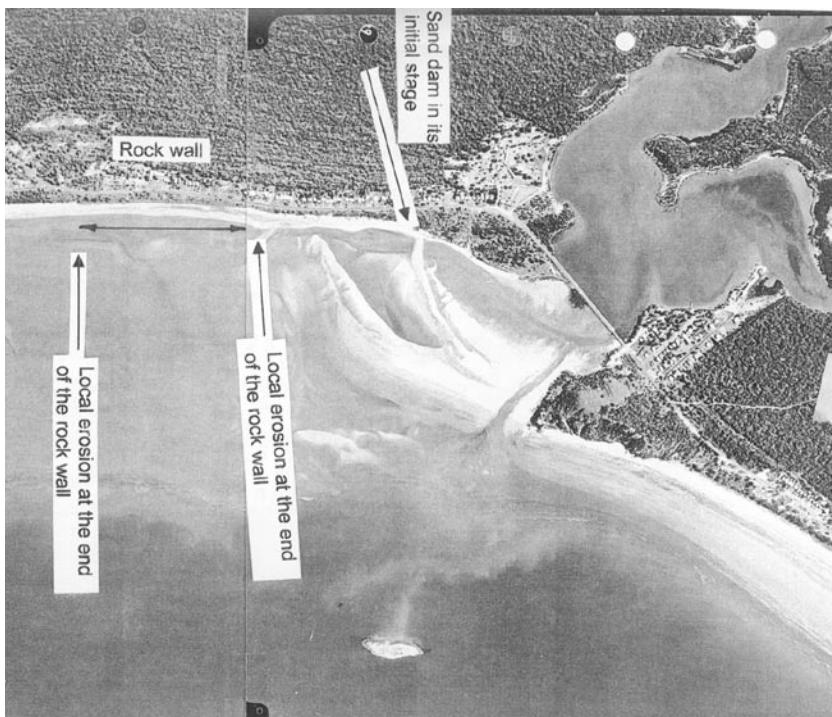
FIGURE 13. Kinka beach, tidal lagoon and the causeway, south view, 1997.

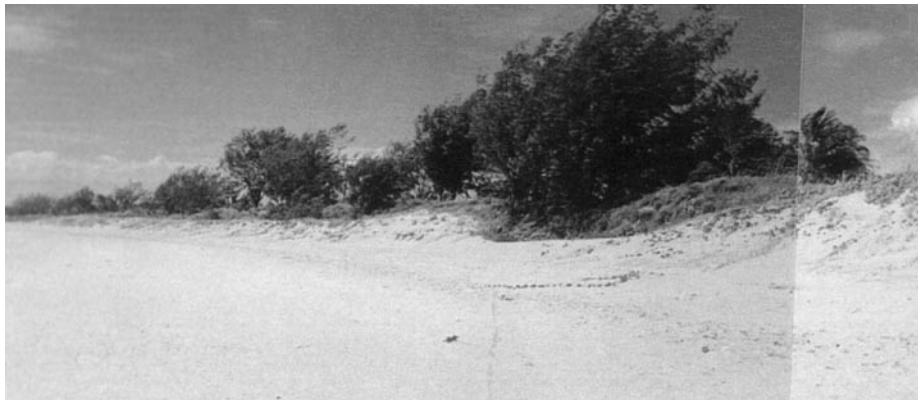
FIGURE 15. Natural sand nourishment results at Kinka beach by 1997.

The engineering department of Central Queensland University and the BPA were key players in finding a solution to this erosion crisis. Kinka Beach's dunes were replenished by natural sand nourishment as a result of constructing a sand dam between 1988 and 1989 (the sand dam in its initial stage is shown in Figure 12). The sand for this dam was gathered by dredging a new channel at the same location where the channel was before the causeway was constructed which was a path from Mulambin Creek directly out to sea. The sand dam was constructed across the southward moving channel that had appeared after the building of the causeway. The sand dam acted to increase the tidal prism by creating a tidal lagoon in front of the causeway (see Figure 13) and reshaping the beach shoreline to its more parabolic statically stable conditions. Between 1993 and 1997, 80 per cent of the rock wall was completely buried under the naturally accumulated sand, and dunes have achieved their natural shape and become covered with grass and shrubs (see Figure 15).⁵⁶ However, further work was required to stop erosion at the southern end of Kinka beach and this continued until 1998. Coastal Engineer Jurek Piorewicz warns that if the sand dam that was constructed in 1989 washes away, then the dunes on Kinka beach will face another erosion crisis.⁵⁷ This beach reshaping solution is part of a recent

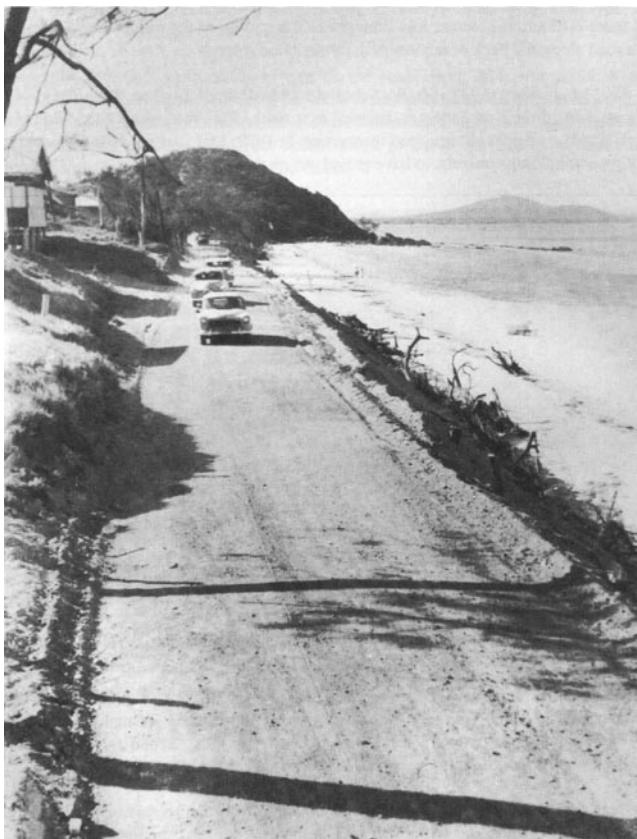
FIGURE 17. Opening of new road on sand dunes, 30 March 1957, north view. Source: Keppel Sands Historical Society, 1995: 68.

At Keppel Sands, a small seaside town in the south west corner of Keppel Bay, houses are located on narrow, but relatively high dunes with only a residential access road between the allotments and the beach.⁵⁸ This road was pushed through heavy sand in the 1950s, basically dissecting a series of sand dunes (see Figure 17). The road gave access from the northern end of the beach to the bluff at the southern end, and was the initiative of the newly formed Keppel Sands Advancement League.⁵⁹ The one-way road was completed and sealed in

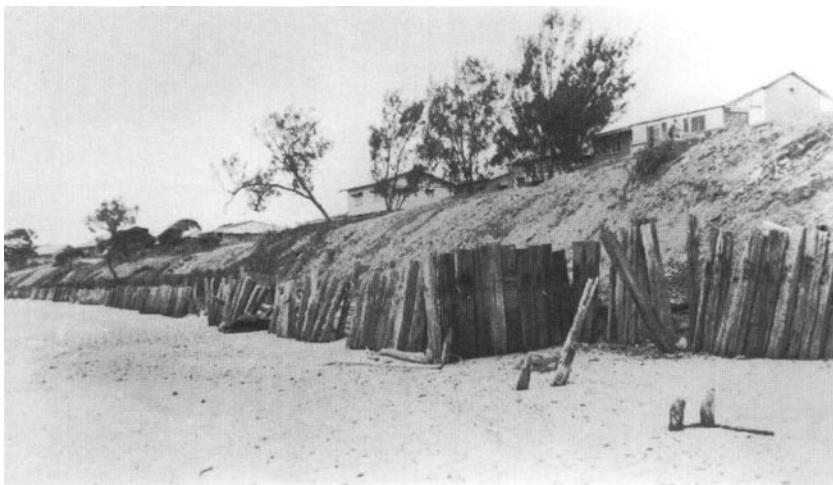
FIGURE 18. Railway sleepers vertically placed to act as a sea wall at Keppel Sands.

A wall made from Ti-tree logs was first constructed along the beach in the 1940s when the local residents attempted to combat natural dune erosion. In the 1950s, another ‘unattractive’ wooden wall was constructed in affected areas, this time out of old railway sleepers obtained from the railway department⁶¹ (see Figure 18). These walls did not prevent dune erosion, and the sleepers were in danger of being scattered across the beach. In 1976, the BPA did not support LSC’s request for approval to extend the sleeper sea wall, saying it was ineffective, dangerous, unattractive, would give a false sense of security to people and was a waste of money.⁶² The wall has been extended over time in a haphazard way whenever money was available to add more rocks and tyres, and now extends for about half of the length of the beach towards the southern end.⁶³ The LSC suggested that the wall along the beach at Keppel Sands be filled with rock quarried from one of the headlands⁶⁴ and this would have scarred a prominent landform.

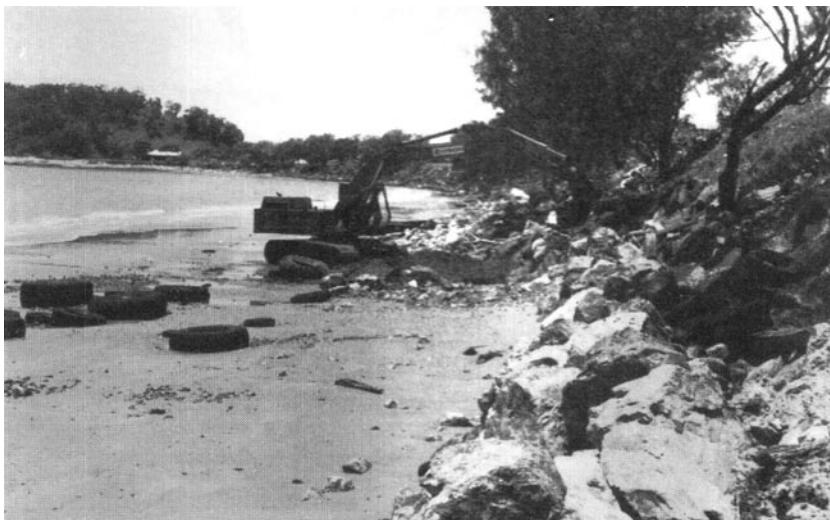
FIGURE 19. LSC constructing a rock wall on Keppel Sands beach. Source: Keppel Sands Historical Society, 1995: 85.

In 1979 the BPA reported that Keppel Sands beach required protective action to prevent erosion. The recommendations included rebuilding the existing sea wall, beach nourishment, and the construction of a groyne.⁶⁵ The sea wall that was first built in the 1940s was maintained by the local community until 1999. The LSC made financial contributions to this project, but did not consider beach erosion a major priority, so the upgrading of the wall was based on ad hoc works rather than predictive modelling.⁶⁶
