# Creating Safety, Courting Disaster on the Lower Shinano River, Japan

Philip C. Brown

## Summary

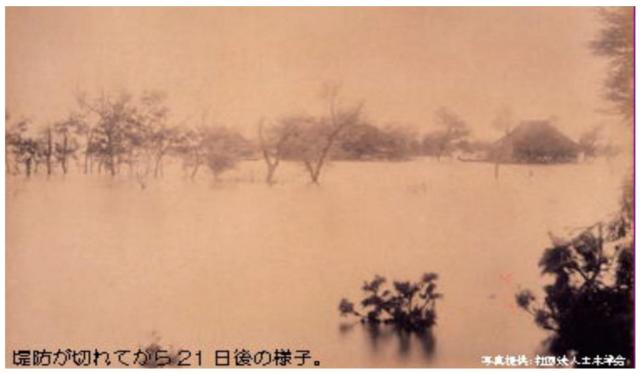
Stagnant floodwaters 21 days after the 1896 flood

On 26 July 1896, after days of rain, the waters of the Shinano River broke through the dikes at Yokota village (southwest of Niigata City) on the Echigo Plain, causing massive flooding. Stagnant water soaked the land for weeks. That event sparked the construction of an overflow channel first proposed in the 1730s, the Okotsu Diversion Channel (Okotsu Bunsui). Today many residents regard it so highly that they have proposed nominating the entire Echigo Plain as a UN cultural heritage site.

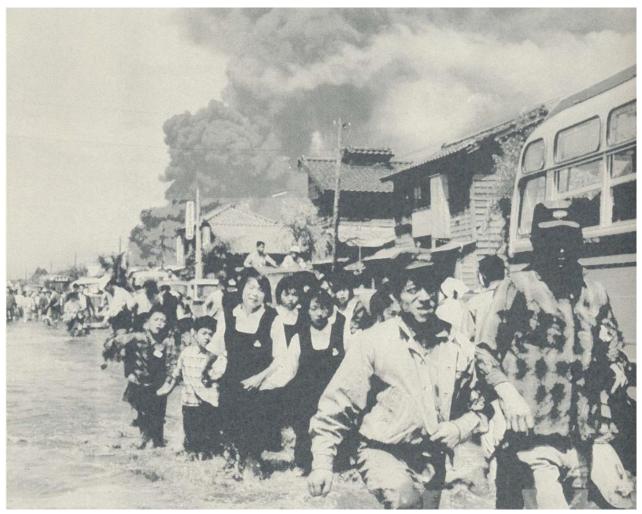
Tsunami-inundated Niigata City, 1964. This image was provided by Niigata Nippo Sha.

Further, residents of this area are subject to a special flood risk, from tsunami events, the impact of which is aggravated by subsidence linked to investments in newly identified safe areas. The tsunami caused by the 1964 earthquake surged far into the city. The waters did not drain for several weeks. With increased subsidence, more areas of the city will be at risk for inundation.
