# Creating Safety, Courting Disaster on the Lower Shinano River, Japan

Philip C. Brown

## Summary

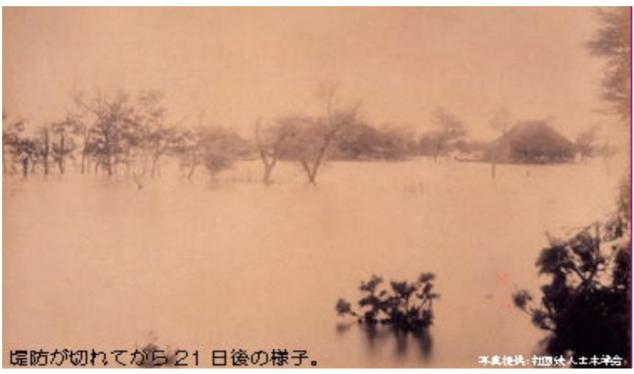
Stagnant floodwaters 21 days after the 1896 flood

On 26 July 1896, after days of rain, the waters of the Shinano River broke through the dikes at Yokota village (southwest of Niigata City) on the Echigo Plain, causing massive flooding. Stagnant water soaked the land for weeks. That event sparked the construction of an overflow channel first proposed in the 1730s, the Okotsu Diversion Channel (Okotsu Bunsui). Today many residents regard it so highly that they have proposed nominating the entire Echigo Plain as a UN cultural heritage site.
