# Creating Safety, Courting Disaster on the Lower Shinano River, Japan

Philip C. Brown

Engineering the Lower Shinano River in northeastern Japan to prevent floods such as those of 1896 ironically contributed to increased loss of property and expanded risk of other flood and tsunami damage as the region developed over the next century.

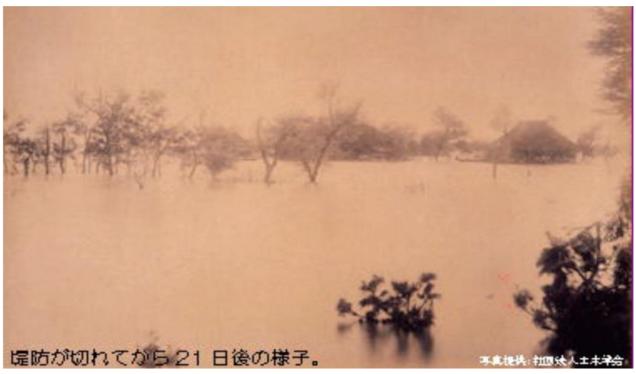
Stagnant floodwaters 21 days after the 1896 flood

On 26 July 1896, after days of rain, the waters of the Shinano River broke through the dikes at Yokota village (southwest of Niigata City) on the Echigo Plain, causing massive flooding. Stagnant water soaked the land for weeks. That event sparked the construction of an overflow channel first proposed in the 1730s, the Okotsu Diversion Channel (Okotsu Bunsui). Today many residents regard it so highly that they have proposed nominating the entire Echigo Plain as a UN cultural heritage site.

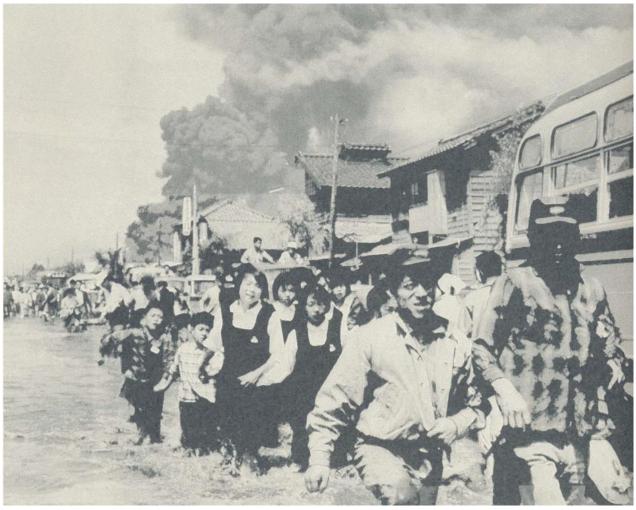
Tsunami-inundated Niigata City, 1964. This image was provided by Niigata Nippo Sha.

Further, residents of this area are subject to a special flood risk, from tsunami events, the impact of which is aggravated by subsidence linked to investments in newly identified safe areas. The tsunami caused by the 1964 earthquake surged far into the city. The waters did not drain for several weeks. With increased subsidence, more areas of the city will be at risk for inundation.
