How a Catastrophic Flood of the Gürbe River Triggered the Rethinking of Local Flood Protection

Melanie Salvisberg

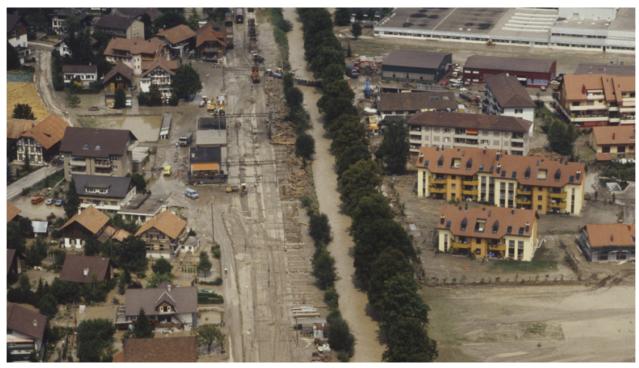
Flooded settlement in Toffen after the event of 29 July 1990.

On the evening of 29 July 1990, after a warm and sunny day, the sky over the Gantrisch region in the Swiss pre-Alps suddenly darkened. A huge thunderstorm appeared—a thunderstorm that not only set a meteorological record, but also changed the approach to flood protection in the Gürbe River area profoundly. Within a short period, the water level rose rapidly, causing the 29-kilometer-long river, a tributary that joins the Aare River south of Bern, to overflow. The water and the bed load caused severe damage to hydraulic structures, farmland, settlements, and traffic facilities near the river. The total cost of the damage was estimated to be 40 million Swiss francs.

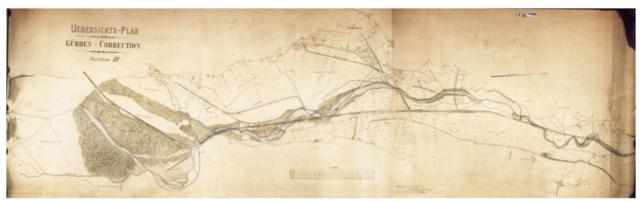
Plan of the natural course of the Gürbe River and the planned channel in Wattenwil, 1881.

Although the Gürbe Valley was known to be flood-prone, due to frequent thunderstorms, steep slopes, soil with low water-storage capacity, and soft rock in the upper reaches, the extent of the event was a shock, especially because extensive measures had been taken to prevent inundations since the mid-nineteenth century. The efforts had started with alterations to the Gürbe River from 1855 to 1881. With the intent of protecting the Gürbe Valley from flooding but also of reclaiming new land from the swampy flood plain, the previously meandering river was straightened and channelized in its flat lower course. In the steep upper reaches, numerous workers erected dozens of wooden and stone dams to control discharge and sediment transport. Dikes to deflect the flow of debris, drainage systems, and slope stabilizations completed the torrent control.

Although the measures ameliorated the flooding situation, the goal of completely preventing inundations was not achieved. Again and again, landslides and floods led to damage. The hydraulic structures were therefore renewed and expanded in numerous consecutive projects. The main focus lay on the upper reaches, where the workers built larger and additional transverse structures (made from concrete since the early 1900s) and completed the slope stabilizations. Similar structures were built in the tributaries. On the valley floor, the channel was extended and widened. In addition to the hydraulic structures, hundreds of hectares of alpine meadow were reforested in the river's catchment area, despite resistance from landowners. In the beginning of the twentieth century, the Gürbe River was embanked and consolidated from its mouth to its source.

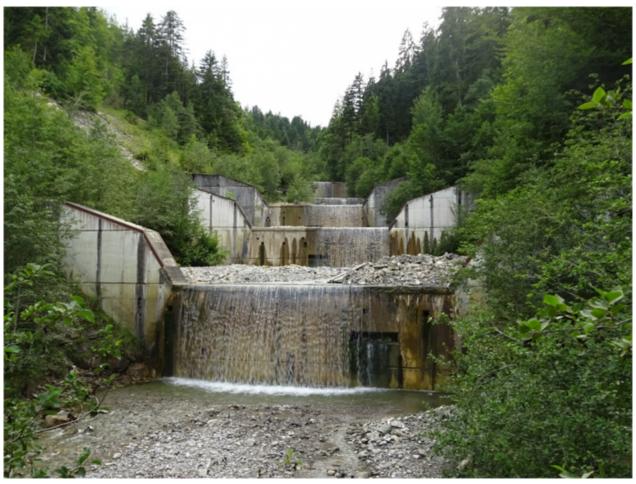
Torrent check dams in the gorge of the Gürbe River.

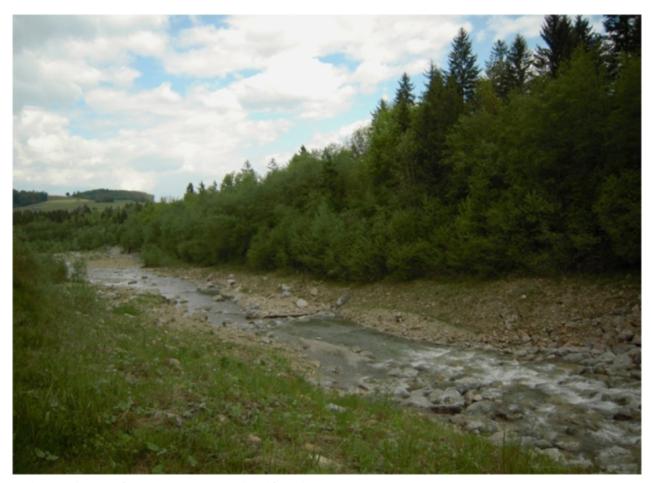
Partly restored stretch of the Gürbe River on the alluvial fan today.

As with many other Swiss rivers, the renaturation of the Gürbe River was only partially feasible due to the intense use of the riverine zone. Larger revitalized stretches could, however, be developed in the area of the river mouth and on the alluvial fan. For the valley floor, the hydraulic engineers planned retention areas.
