The Search for George DeBaptiste's House: The Crooked Creek Flood of 1846

Christopher Baas and Darrin L. Rubino

Summary

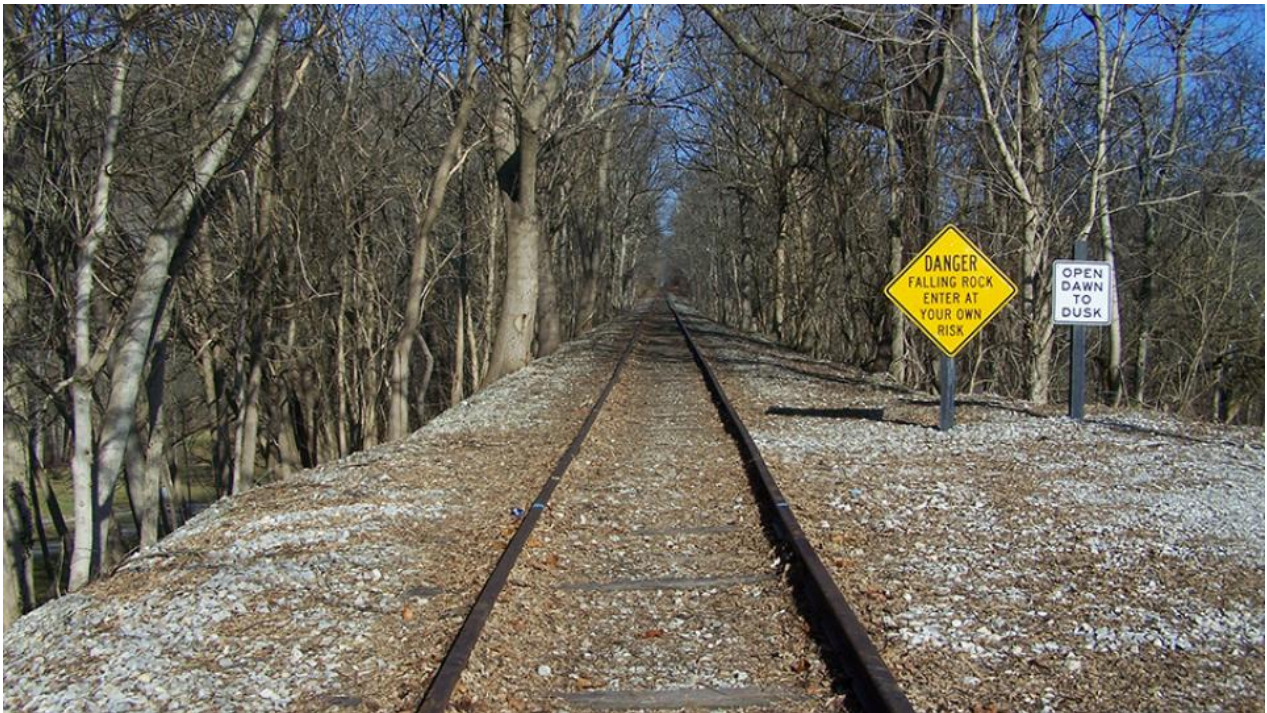
Photograph of the Madison, Indianapolis & Lafayette Railroad incline looking north.

The Madison, Indianapolis & Lafayette Railroad is the state’s first railroad (1841), and infamous for its “incline,” a section of track with the steepest slope of any railroad in the country (412 meters rise over 2.1 kilometers of track). Construction required the removal of as much as 38 meters of limestone. To establish a consistent slope from the city to the bluff top, Crooked Creek valley was filled with nearly 21 meters of stone and soil; the creek was channeled in a culvert beneath the embankment.

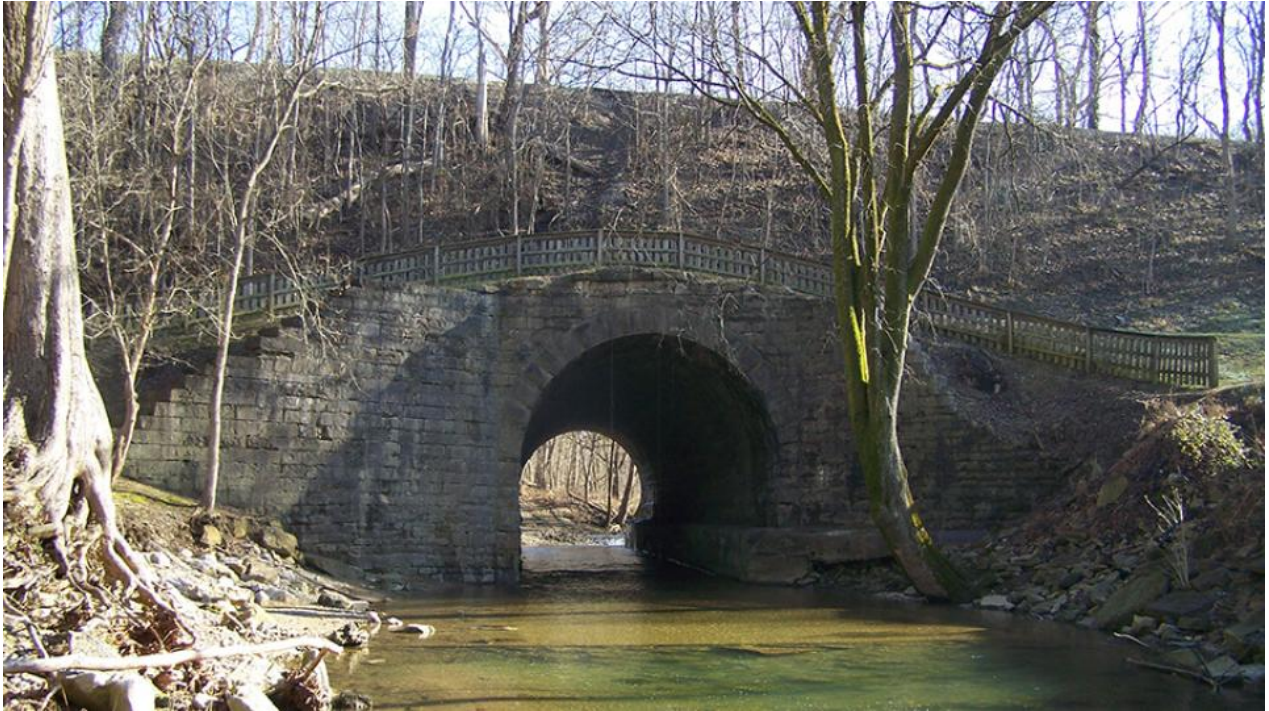
Photograph of the culvert carrying Crooked Creek beneath the Madison, Indianapolis & Lafayette Railroad. The devastation of the Crooked Creek Flood was intensified when the culvert became clogged with debris. The historic culvert was destroyed in the flood.

With computer-aided technology, we tested a scenario where the railroad culvert clogs with debris to create a pool of water extending upstream to the DeBaptiste property. DEM data (1 meter resolution) was used in Geographic Information Systems Software to identify key elevations for the DeBaptiste property (149 meters representing 0.3 meters of floodwater on the property), the creek at the culvert (135 meters), and the top of the railroad embankment (155 meters, or 20 meters above the creek). We noted that DeBaptiste's property is only 41 meters from, and 6 meters higher than, Crooked Creek. We acknowledged the limitations that historic accounts included little regarding water depth and that our current topographic data may not precisely replicate Madison's 1846 landscape. We highlighted the house's 149-meter contour elevation to see if a reservoir extended from the railroad culvert to the house site in the case that the culvert was closed. As a result, a 73-hectare pool is created that (like that described in the article from the *Madison Republic*) extends upstream beyond the house and the confluence with Dugan Hollow.

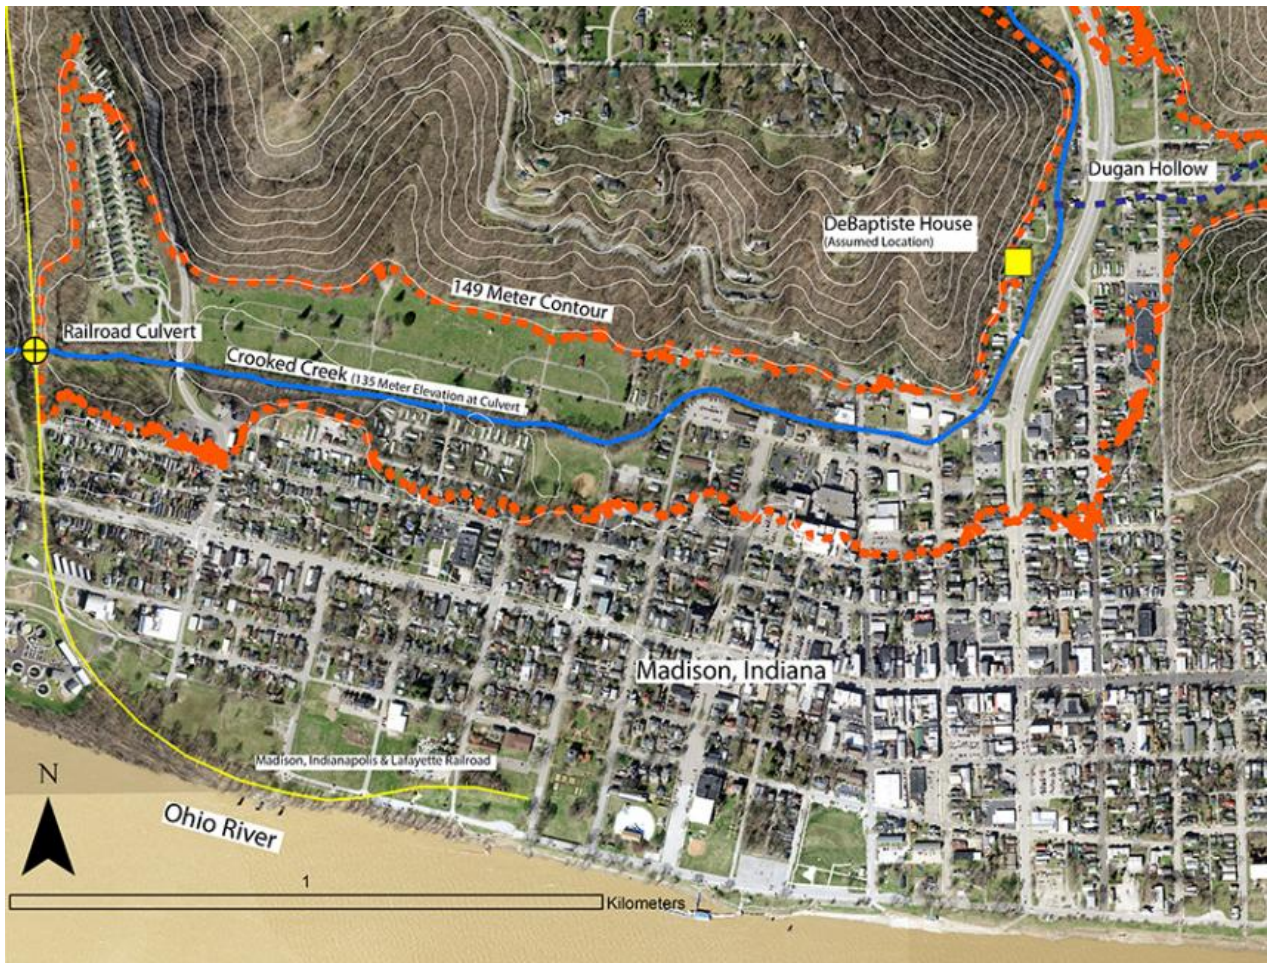
Map of Madison, Indiana showing the location of the railroad culvert and the DeBaptiste property. The white lines represent 10-meter contours and demonstrate how Madison was built on a riverside plateau adjacent to substantial bluffs. The dashed red line represents the 149 m contour line, which is the elevation of the DeBaptiste property and the elevation floodwaters would need to reach to affect buildings on the property.
 (Click to enlarge image)

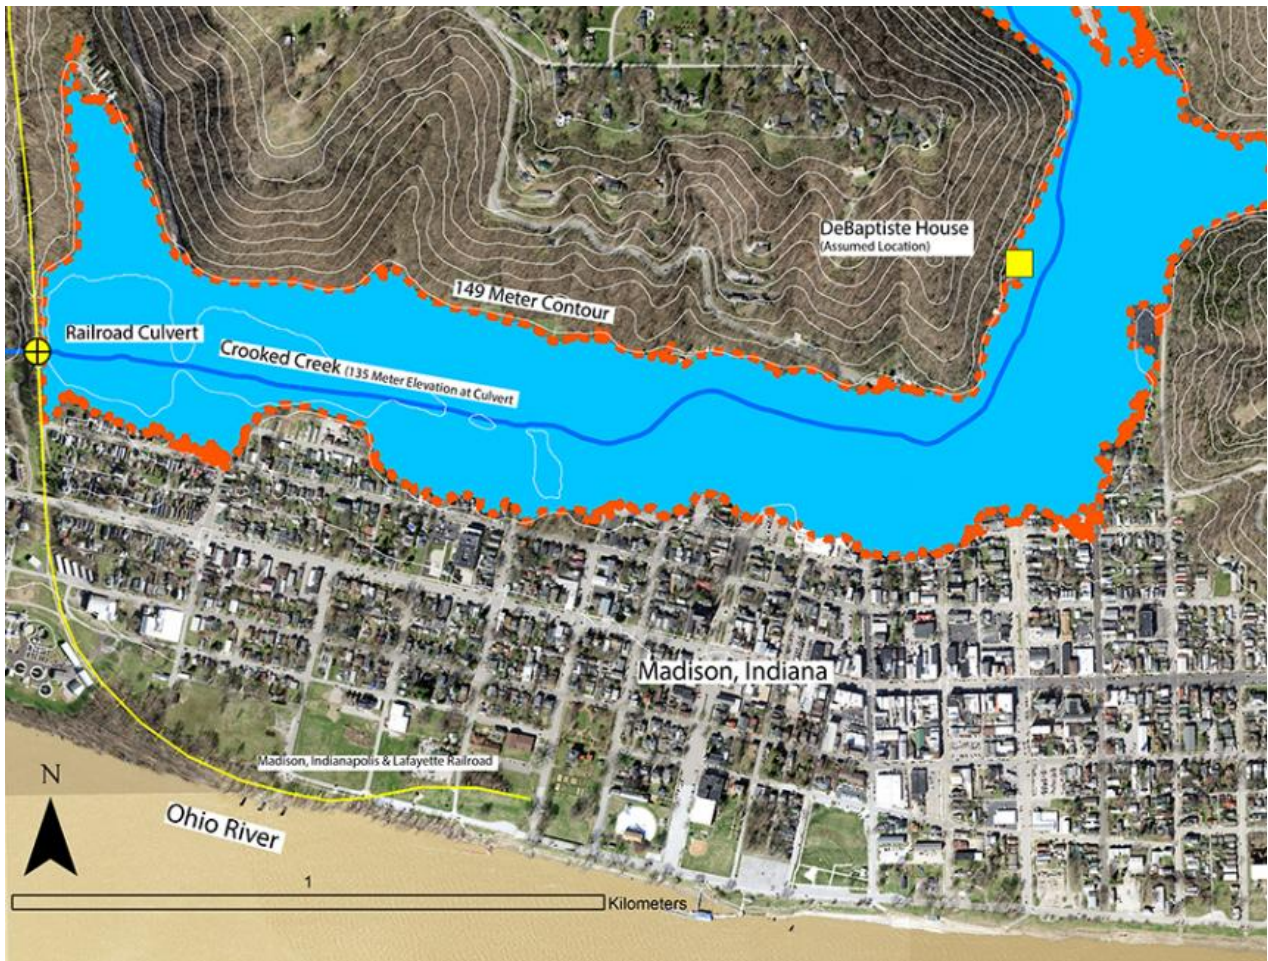
Map of Madison, Indiana showing a reconstruction of the potential impact of the Crooked Creek Flood. A reservoir is created when the railroad culvert becomes clogged with debris. The image shows that residential and stream-side industrial sections of the city are affected, and that the floodwaters extend to and beyond the DeBaptiste property site.

Our test was able to demonstrate the severity of the disaster. Hypothetically, floodwater pools to a depth of 13 meters at the railroad embankment, and the reservoir extends to the DeBaptiste property (and 1.6 kilometers beyond). While the result of the study does not prove the house was lost in the disaster, it does suggest that if the initial flooding did not destroy the house, the flow from Dugan Hollow and the rush of floodwater following the breach in the embankment could have severely damaged the structure.
