## The Search for George DeBaptiste's House: The Crooked Creek Flood of 1846

Christopher Baas and Darrin L. Rubino

We used archival sources and Geographic Information Systems data to demonstrate the feasibility of the 1846 Crooked Creek Flood (Madison, Indiana, USA) having destroyed the home connected to abolitionist and Underground Railroad leader George DeBaptiste.

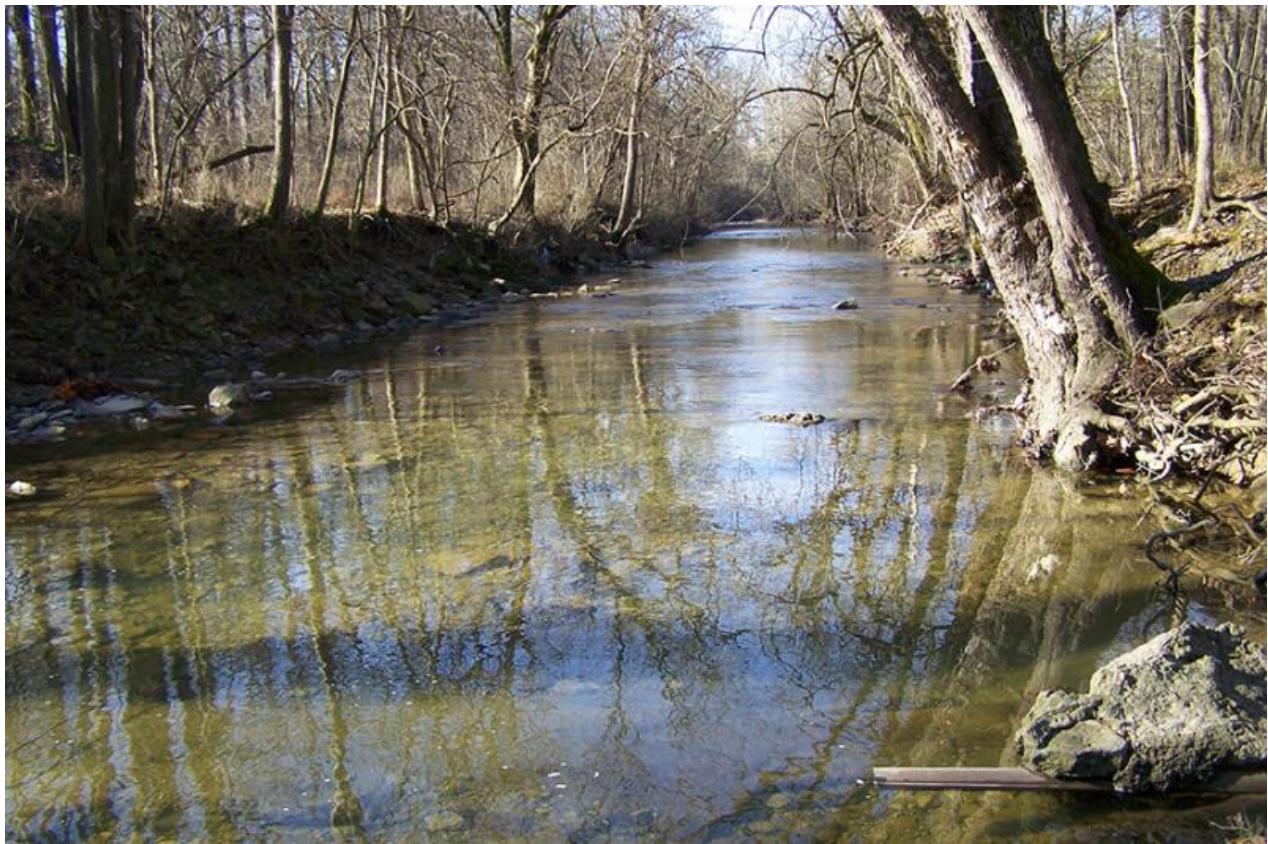
Photograph of Crooked Creek at its location on the north boundary of Madison, Indiana (looking east).

between the base of the bluffs and the north side of the town, and empties into the Ohio immediately west of Madison. Branches of the creek, like Dugan Hollow, drain adjacent hills.

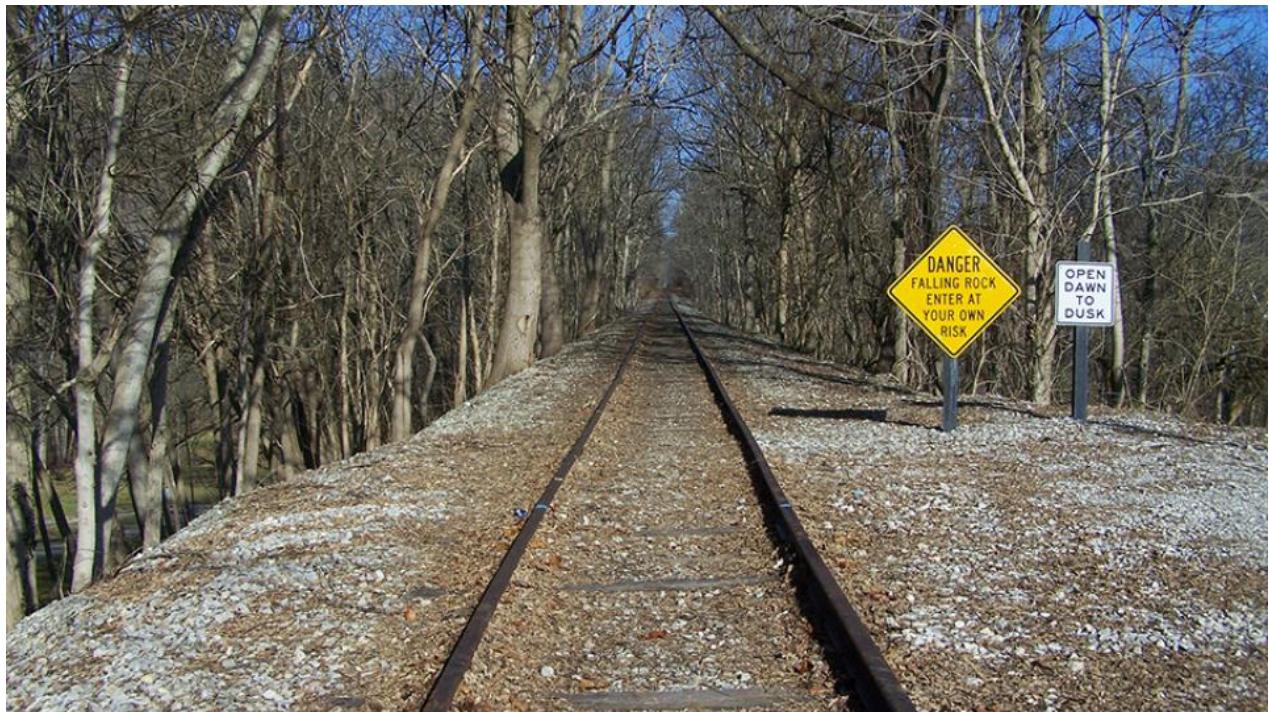
Photograph of the Madison, Indianapolis & Lafayette Railroad incline looking north.

The Madison, Indianapolis & Lafayette Railroad is the state's first railroad (1841), and infamous for its "incline," a section of track with the steepest slope of any railroad in the country (412 meters rise over 2.1 kilometers of track). Construction required the removal of as much as 38 meters of limestone. To establish a consistent slope from the city to the bluff top, Crooked Creek valley was filled with nearly 21 meters of stone and soil; the creek was channeled in a culvert beneath the embankment.

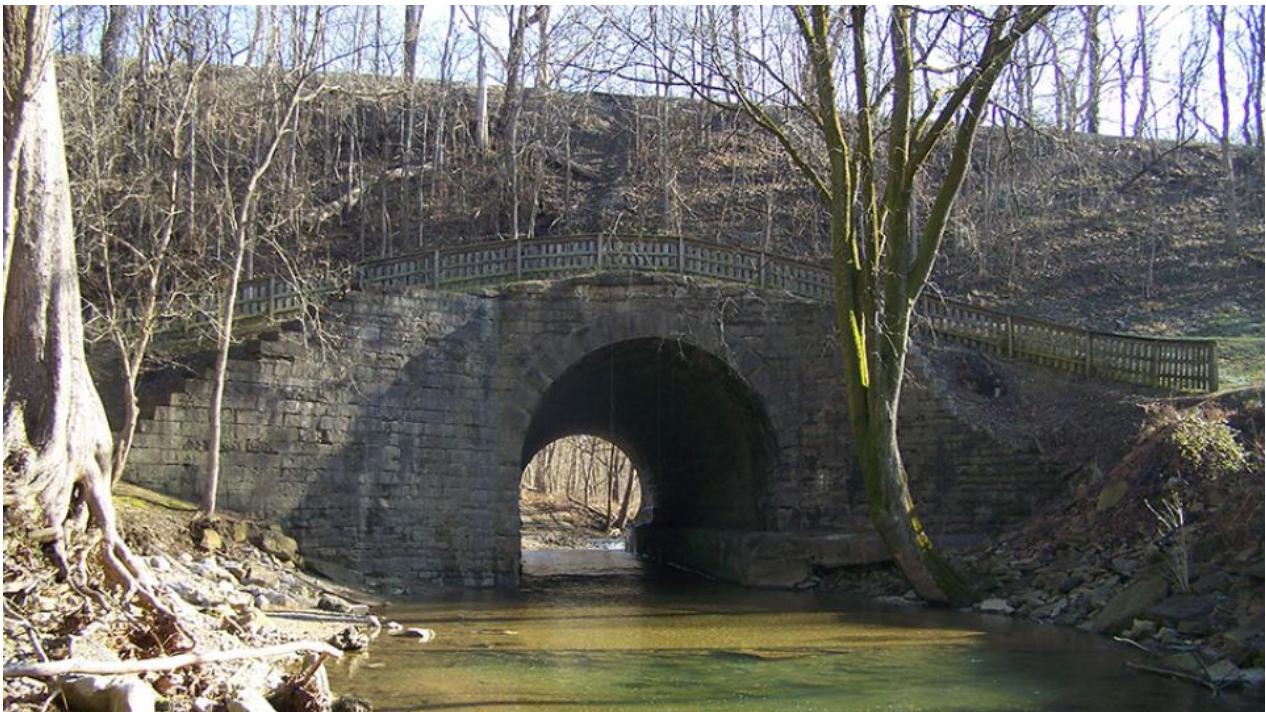
Photograph of the culvert carrying Crooked Creek beneath the Madison, Indianapolis & Lafayette Railroad. The devastation of the Crooked Creek Flood was intensified when the culvert became clogged with debris. The historic culvert was destroyed in the flood.

With computer-aided technology, we tested a scenario where the railroad culvert clogs with debris to create a pool of water extending upstream to the DeBaptiste property. DEM data (1 meter resolution) was used in Geographic Information Systems Software to identify key elevations for the DeBaptiste property (149 meters representing 0.3 meters of floodwater on the property), the creek at the culvert (135 meters), and the top of the railroad embankment (155 meters, or 20 meters above the creek). We noted that DeBaptiste's property is only 41 meters from, and 6 meters higher than, Crooked Creek. We acknowledged the limitations that historic accounts included little regarding water depth and that our current topographic data may not precisely replicate Madison's 1846 landscape. We highlighted the house's 149-meter contour elevation to see if a reservoir extended from the railroad culvert to the house site in the case that the culvert was closed. As a result, a 73-hectare pool is created that (like that described in the article from the *Madison Republic*) extends upstream beyond the house and the confluence with Dugan Hollow.

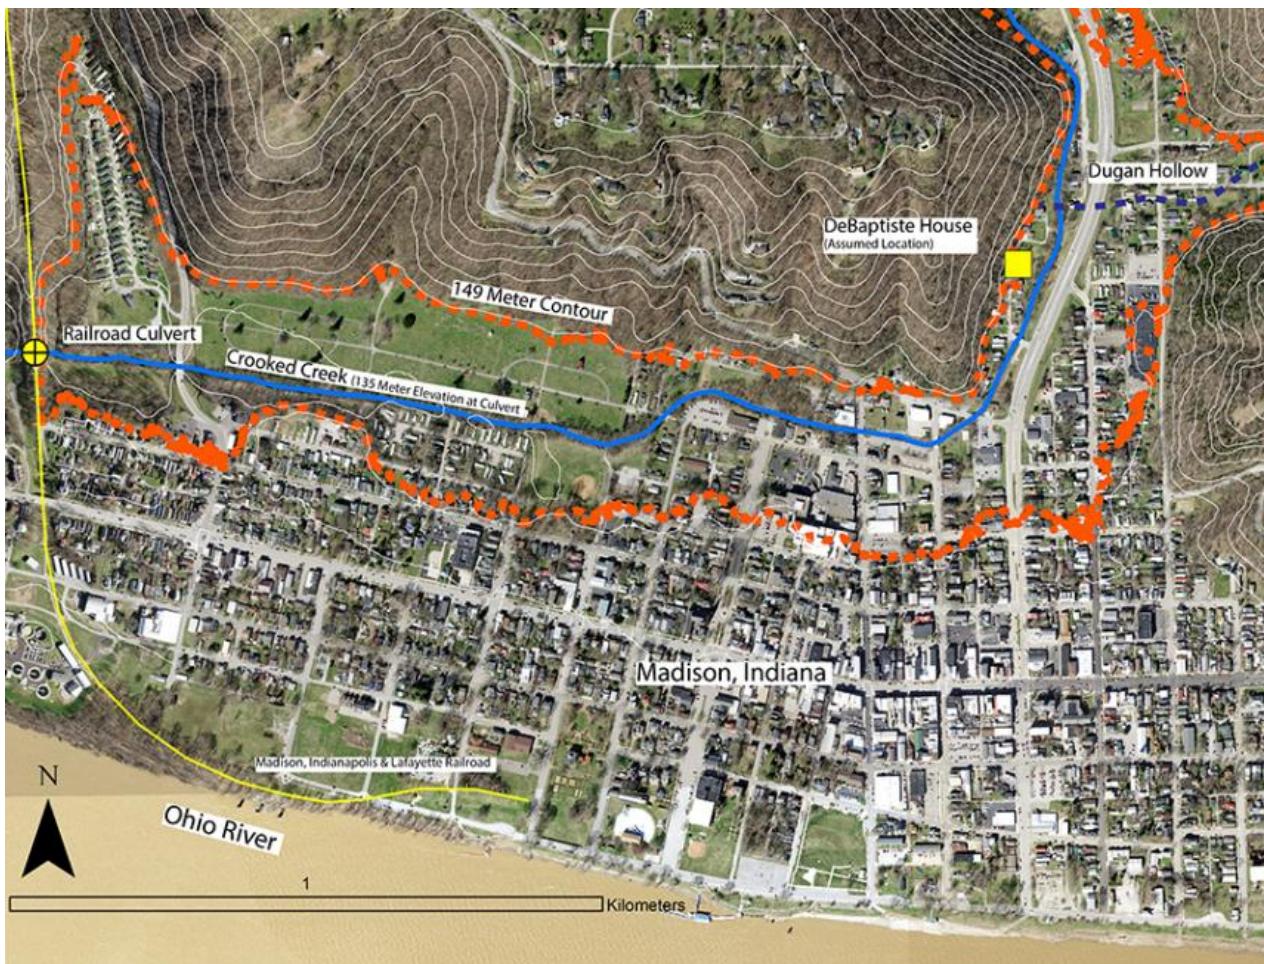
Map of Madison, Indiana showing the location of the railroad culvert and the DeBaptiste property. The white lines represent 10-meter contours and demonstrate how Madison was built on a riverside plateau adjacent to substantial bluffs. The dashed red line represents the 149 m contour line, which is the elevation of the DeBaptiste property and the elevation floodwaters would need to reach to affect buildings on the property.
