## The Search for George DeBaptiste's House: The Crooked Creek Flood of 1846

Christopher Baas and Darrin L. Rubino

### Summary

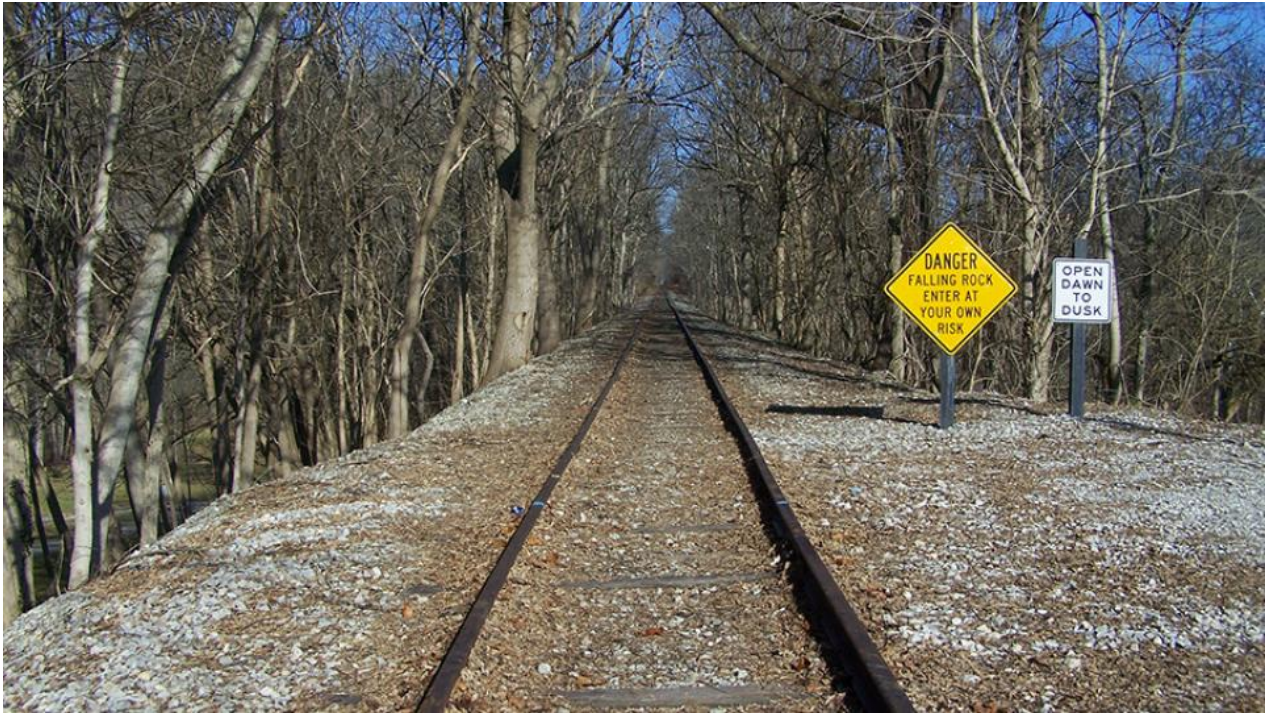
Photograph of the Madison, Indianapolis & Lafayette Railroad incline looking north.

The Madison, Indianapolis & Lafayette Railroad is the state's first railroad (1841), and infamous for its "incline," a section of track with the steepest slope of any railroad in the country (412 meters rise over 2.1 kilometers of track). Construction required the removal of as much as 38 meters of limestone. To establish a consistent slope from the city to the bluff top, Crooked Creek valley was filled with nearly 21 meters of stone and soil; the creek was channeled in a culvert beneath the embankment.

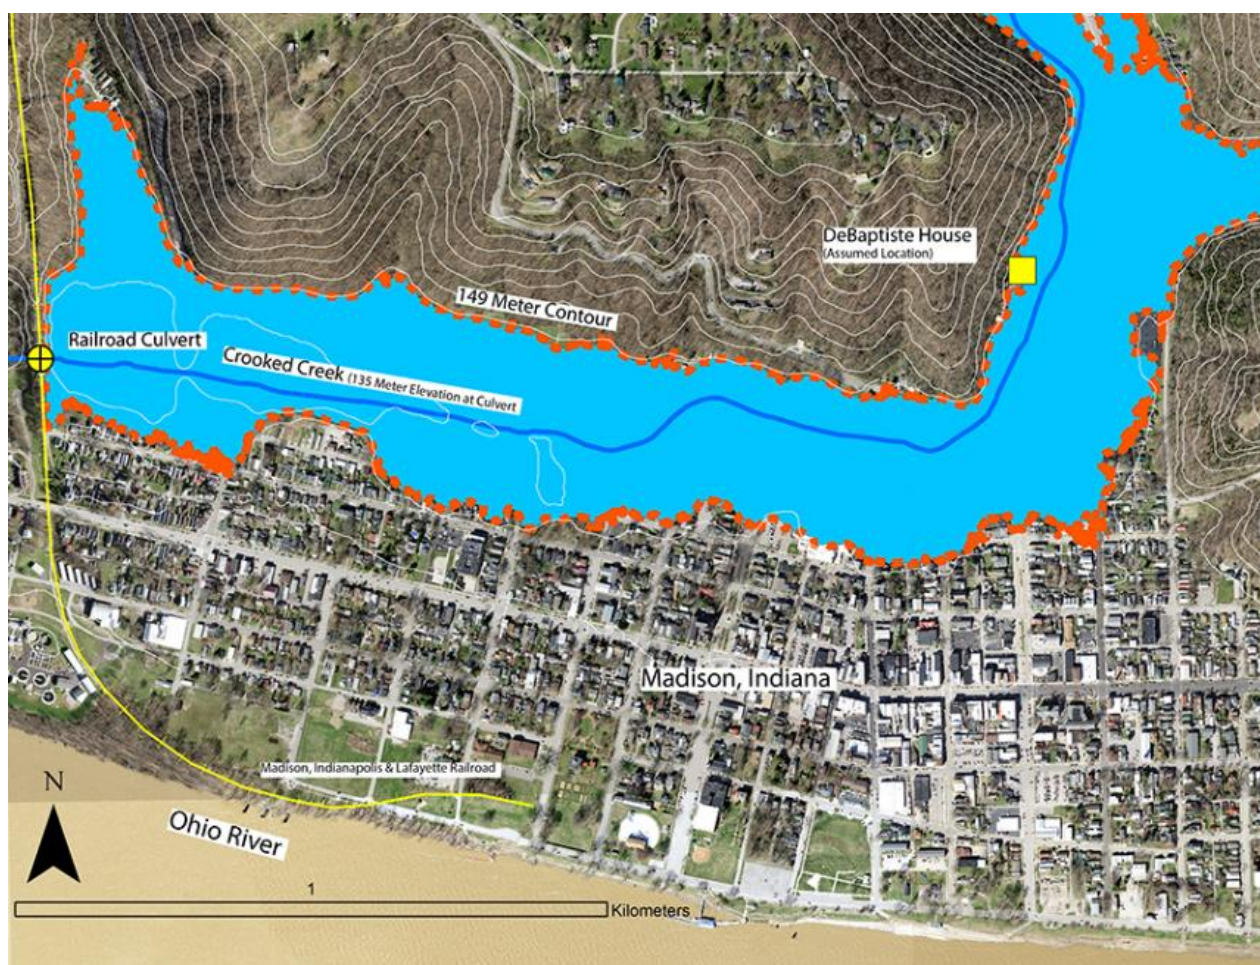
Map of Madison, Indiana showing a reconstruction of the potential impact of the Crooked Creek Flood. A reservoir is created when the railroad culvert becomes clogged with debris. The image shows that residential and stream-side industrial sections of the city are affected, and that the floodwaters extend to and beyond the DeBaptiste property site.

Our test was able to demonstrate the severity of the disaster. Hypothetically, floodwater pools to a depth of 13 meters at the railroad embankment, and the reservoir extends to the DeBaptiste property (and 1.6 kilometers beyond). While the result of the study does not prove the house was lost in the disaster, it does suggest that if the initial flooding did not destroy the house, the flow from Dugan Hollow and the rush of floodwater following the breach in the embankment could have severely damaged the structure.
