The Search for George DeBaptiste's House: The Crooked Creek Flood of 1846

Christopher Baas and Darrin L. Rubino

Summary

We used archival sources and Geographic Information Systems data to demonstrate the feasibility of the 1846 Crooked Creek Flood (Madison, Indiana, USA) having destroyed the home connected to abolitionist and Underground Railroad leader George DeBaptiste.

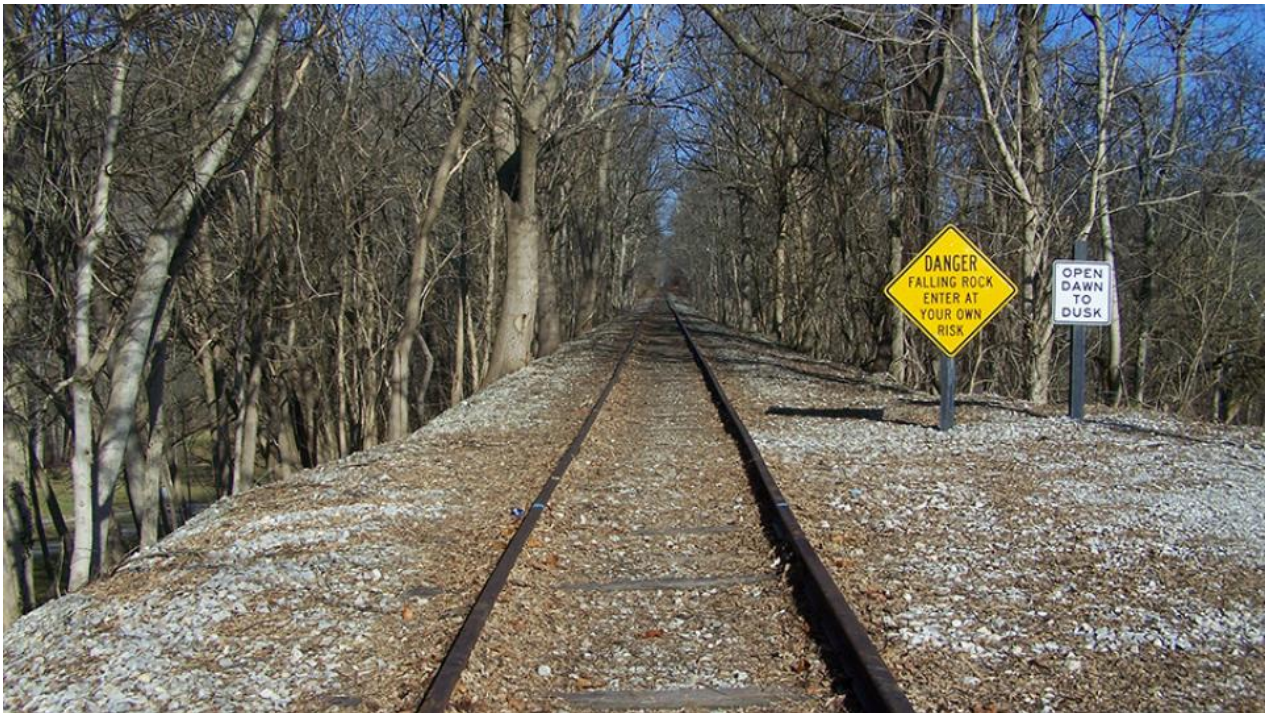
Photograph of the Madison, Indianapolis & Lafayette Railroad incline looking north.

The Madison, Indianapolis & Lafayette Railroad is the state's first railroad (1841), and infamous for its “incline,” a section of track with the steepest slope of any railroad in the country (412 meters rise over 2.1 kilometers of track). Construction required the removal of as much as 38 meters of limestone. To establish a consistent slope from the city to the bluff top, Crooked Creek valley was filled with nearly 21 meters of stone and soil; the creek was channeled in a culvert beneath the embankment.

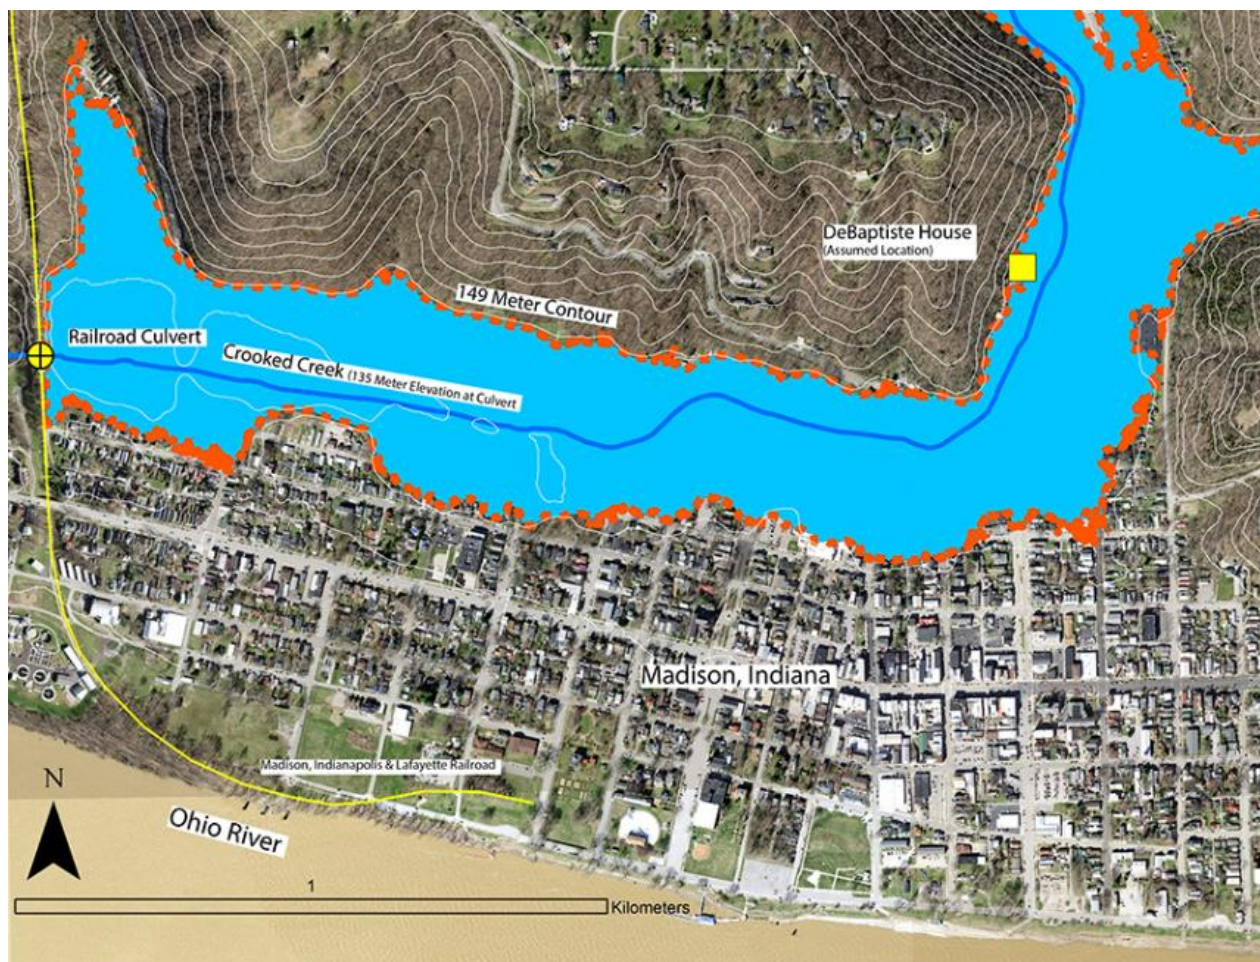
Map of Madison, Indiana showing a reconstruction of the potential impact of the Crooked Creek Flood. A reservoir is created when the railroad culvert becomes clogged with debris. The image shows that residential and stream-side industrial sections of the city are affected, and that the floodwaters extend to and beyond the DeBaptiste property site.
(Click to enlarge image)

Our test was able to demonstrate the severity of the disaster. Hypothetically, floodwater pools to a depth of 13 meters at the railroad embankment, and the reservoir extends to the DeBaptiste property (and 1.6 kilometers beyond). While the result of the study does not prove the house was lost in the disaster, it does suggest that if the initial flooding did not destroy the house, the flow from Dugan Hollow and the rush of floodwater following the breach in the embankment could have severely damaged the structure.
