The Search for George DeBaptiste's House: The Crooked Creek Flood of 1846

Christopher Baas and Darrin L. Rubino

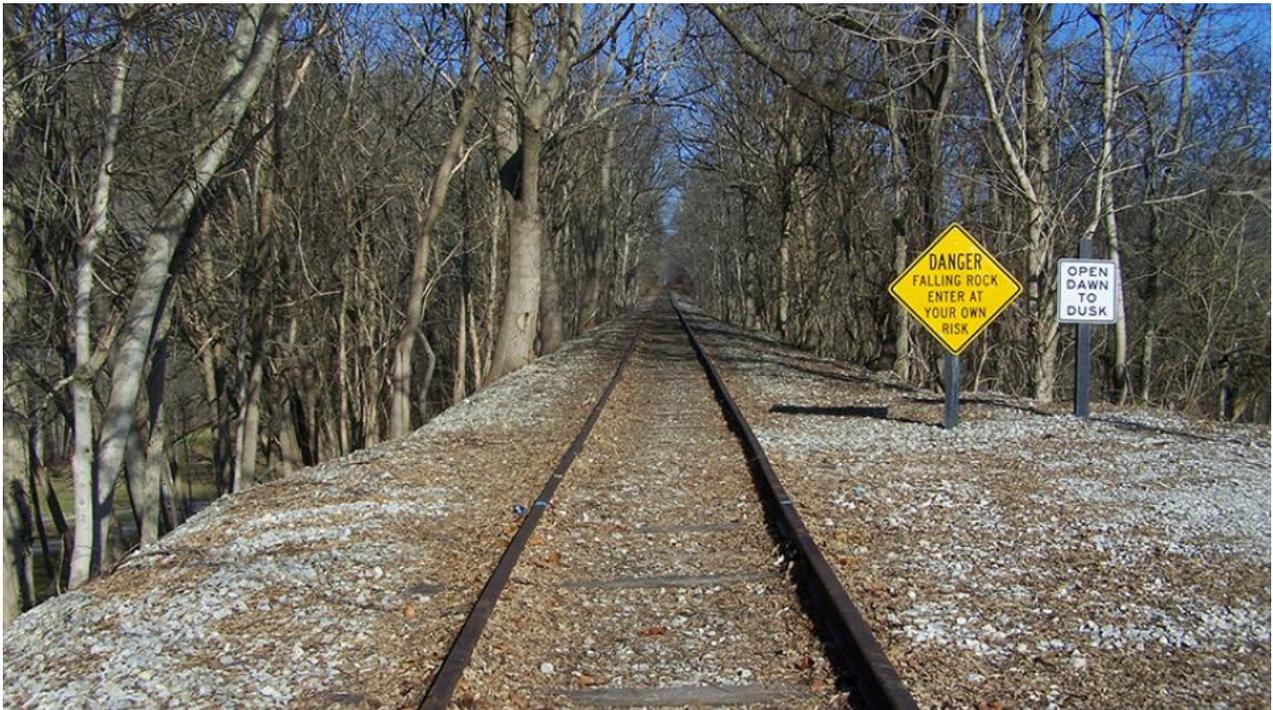
Photograph of the Madison, Indianapolis & Lafayette Railroad incline looking north.

The Madison, Indianapolis & Lafayette Railroad is the state’s first railroad (1841), and infamous for its “incline,” a section of track with the steepest slope of any railroad in the country (412 meters rise over 2.1 kilometers of track). Construction required the removal of as much as 38 meters of limestone. To establish a consistent slope from the city to the bluff top, Crooked Creek valley was filled with nearly 21 meters of stone and soil; the creek was channeled in a culvert beneath the embankment.

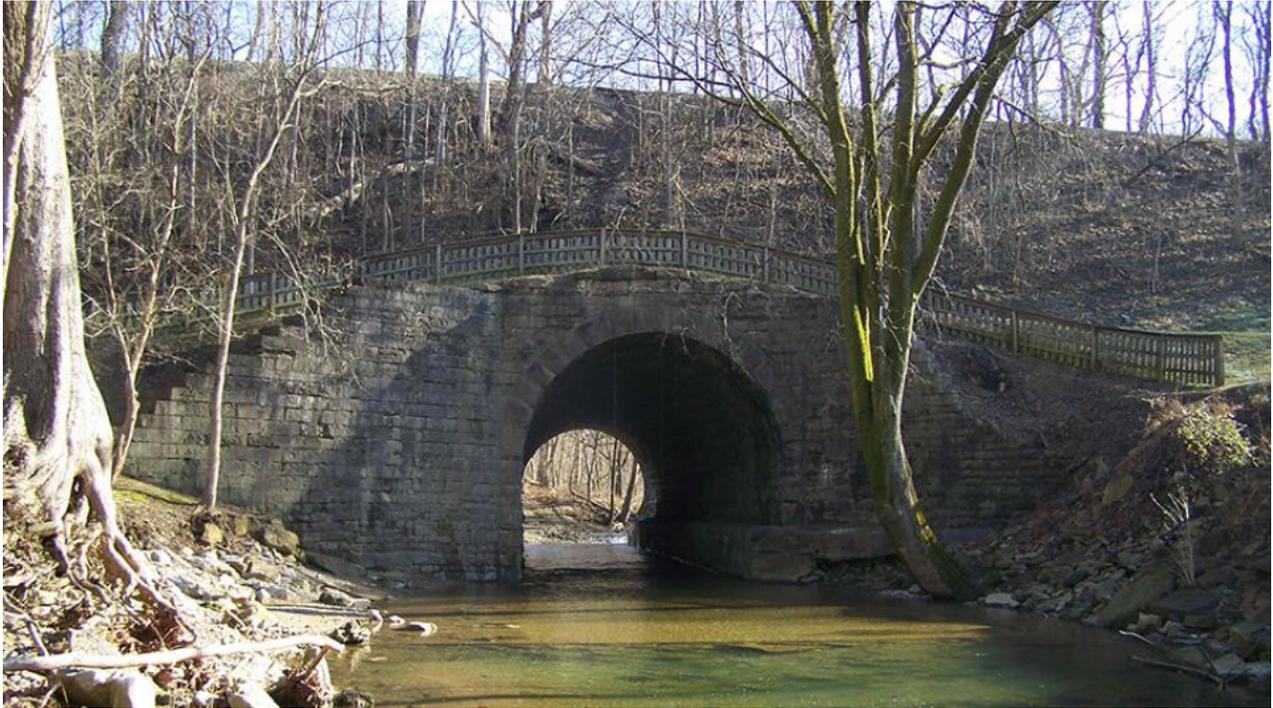
Photograph of the culvert carrying Crooked Creek beneath the Madison, Indianapolis & Lafayette Railroad. The devastation of the Crooked Creek Flood was intensified when the culvert became clogged with debris. The historic culvert was destroyed in the flood.

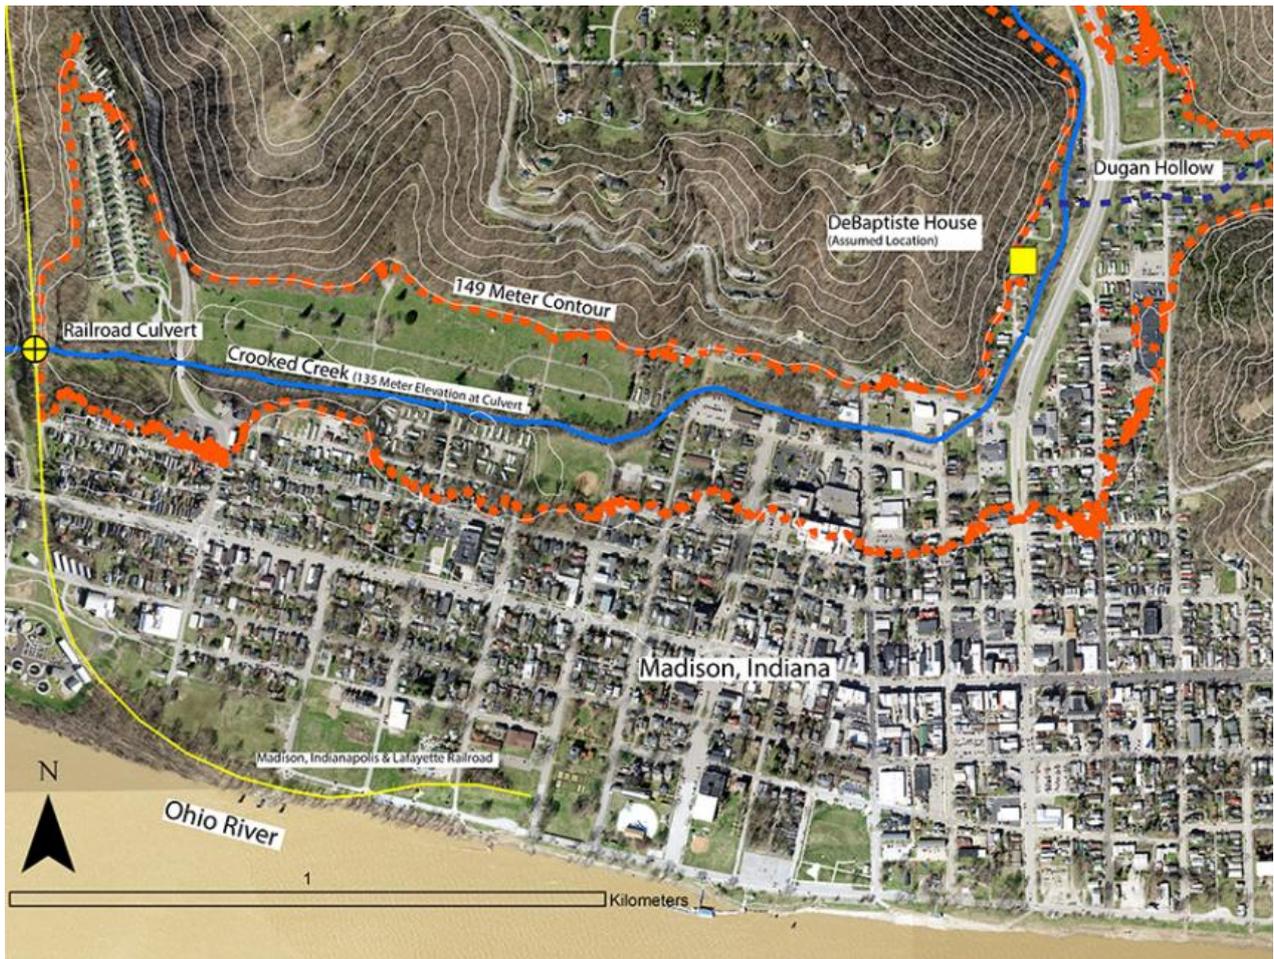
Map of Madison, Indiana showing the location of the railroad culvert and the DeBaptiste property. The white lines represent 10-meter contours and demonstrate how Madison was built on a riverside plateau adjacent to substantial bluffs. The dashed red line represents the 149 m contour line, which is the elevation of the DeBaptiste property and the elevation floodwaters would need to reach to affect buildings on the property.
(Click to enlarge image)

With computer-aided technology, we tested a scenario where the railroad culvert clogs with debris to create a pool of water extending upstream to the DeBaptiste property. DEM data (1 meter resolution) was used in Geographic Information Systems Software to identify key elevations for the DeBaptiste property (149 meters representing 0.3 meters of floodwater on the property), the creek at the culvert (135 meters), and the top of the railroad embankment (155 meters, or 20 meters above the creek). We noted that DeBaptiste's property is only 41 meters from, and 6 meters higher than, Crooked Creek. We acknowledged the limitations that historic accounts included little regarding water depth and that our current topographic data may not precisely replicate Madison's 1846 landscape. We highlighted the house's 149-meter contour elevation to see if a reservoir extended from the railroad culvert to the house site in the case that the culvert was closed. As a result, a 73-hectare pool is created that (like that described in the article from the *Madison Republic*) extends upstream beyond the house and the confluence with Dugan Hollow.

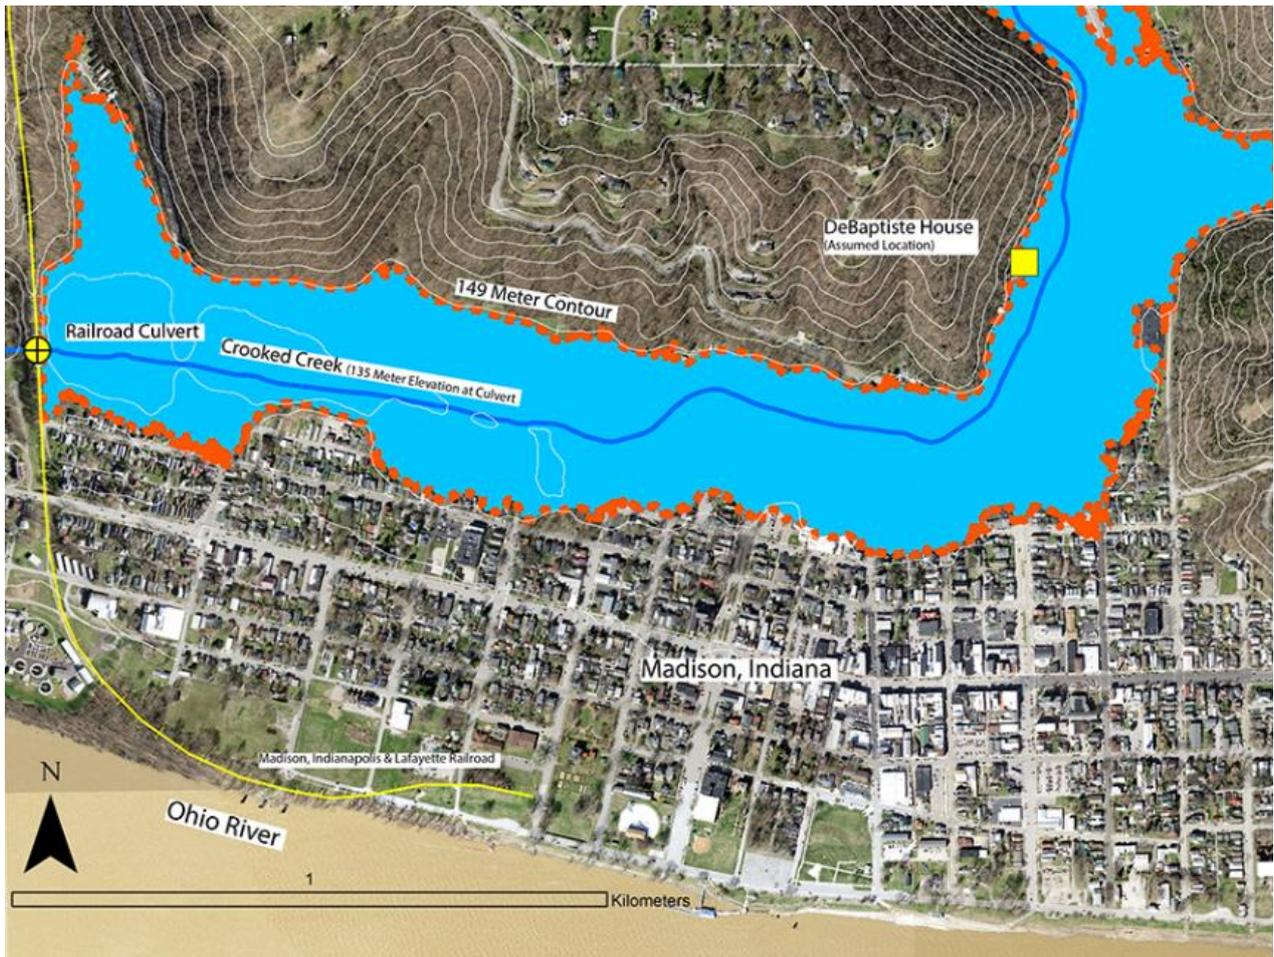
Map of Madison, Indiana showing a reconstruction of the potential impact of the Crooked Creek Flood. A reservoir is created when the railroad culvert becomes clogged with debris. The image shows that residential and stream-side industrial sections of the city are affected, and that the floodwaters extend to and beyond the DeBaptiste property site.

Our test was able to demonstrate the severity of the disaster. Hypothetically, floodwater pools to a depth of 13 meters at the railroad embankment, and the reservoir extends to the DeBaptiste property (and 1.6 kilometers beyond). While the result of the study does not prove the house was lost in the disaster, it does suggest that if the initial flooding did not destroy the house, the flow from Dugan Hollow and the rush of floodwater following the breach in the embankment could have severely damaged the structure.
