Full citation: Skokanova, Hana. "The Impact of River Engineering Works on the Dyje River floodplain in the Czech Republic" *Global Environment 2* (2008): 83–111.
<http://www.environmentandsociety.org/node/4460>.

The Impact of River Engineering Works on the Dyje River Floodplain in the Czech Republic*

Hana Skokanova

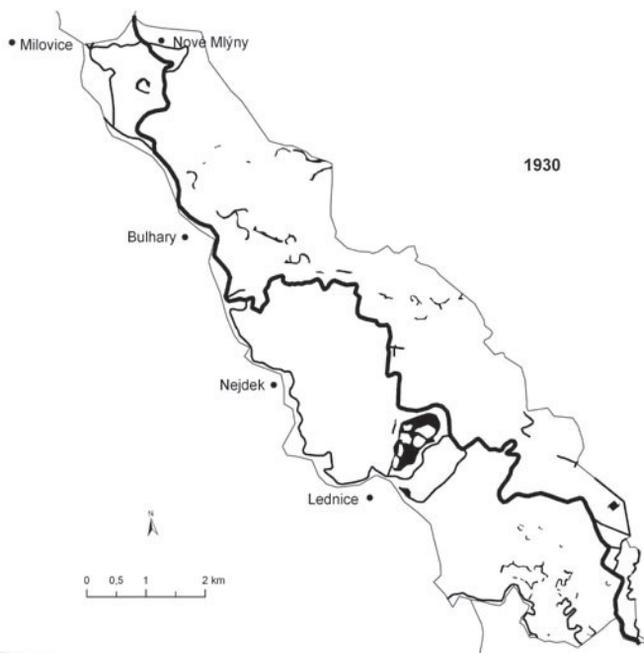
Figure 4 Changes in section 3 of the Dyje River

One of the most significant changes in *Section 3* was the digging of a completely new channel for the Dyje and its embankment from Bulhary village to Janův castle (river km 33.5), in the middle stretch of the section, between 1975 and 1988. The maps (Fig 4) clearly show the effects of the dry periods that occurred at the end of the 19th century and in the 1910s and '20s, when many streams and oxbows dried up and were used as meadows or pastures. This is especially evident along the left bank of the Dyje and in the southern part of the section. The situation changed during the 1930s-40s, when the groundwater supply of some oxbows, mainly along the right bank in the middle part of the section, between the villages of Lednice and Nejdeč (river km 36-40), was renewed. This situation is illustrated by the map for the 1952-1955 period. In 1990-1999, forest water channels in the forest districts of Horní les (between Lednice and Nejdeč) and Dolní les (north of Včelínek creek in the southern part of the section) were restored, as can be seen in the maps for the 1991-1992 and 2002-2006 periods. A comparative

examination of sinuosity in this section at different periods clearly indicates that it was high in the first two periods and subsequently decreased, to increase again in the 1950s. Throughout all four periods, the Dyje maintained a meandering course. The last two periods are characterised by very low sinuosity as a consequence of river en-

gineering works, notably the digging of the new channel mentioned above. Thus, in both periods the Dyje had an only slightly sinuous channel. The decrease in sinuosity documented in the maps from the 1921-1952 period may have been the result of natural fluvial processes.

This section presents an excellent example of the impact of river engineering works on land use. The engineering works allowed the ploughing of permanent grassland, especially along the left bank of the Dyje. Since the works started in the second half of the 20th century, a significant decrease in permanent grassland and a concomitant increase in arable land is observable in 1991-1992 and 2002-2006.

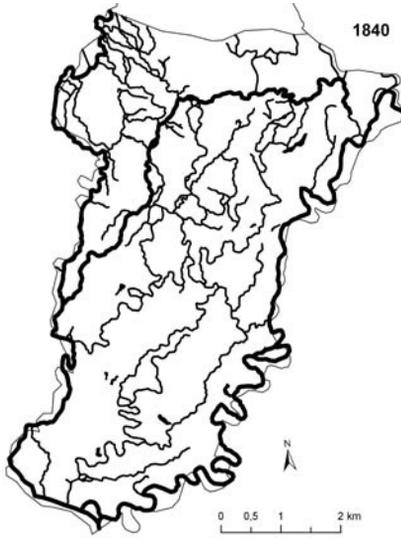
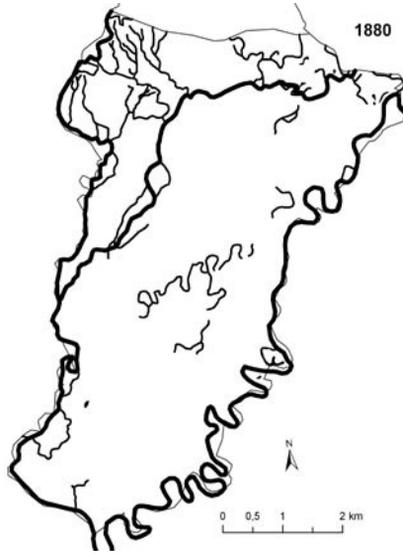
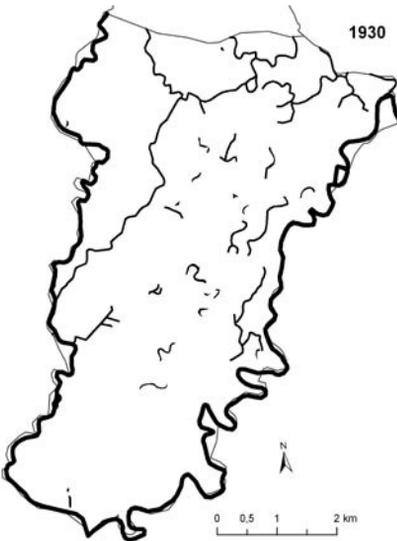
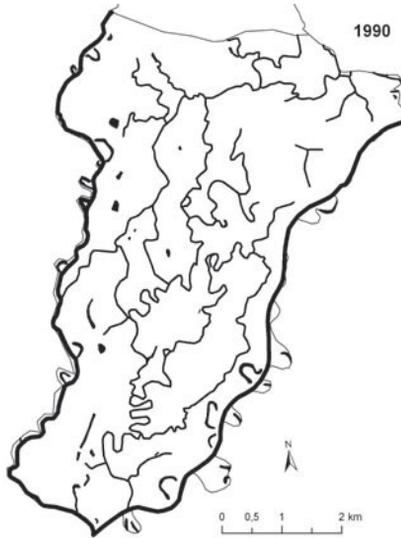
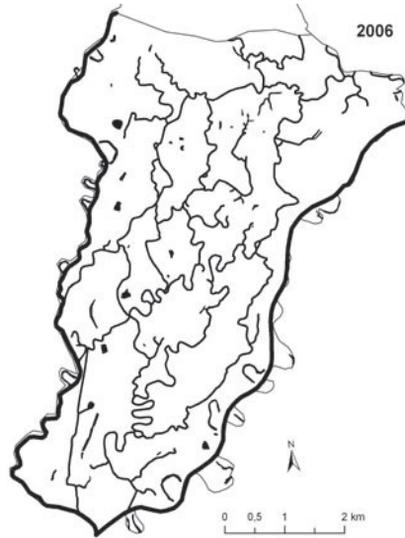
Figure 6 Changes in section 5 of the Dyje River

In *Section 5*, the highest total river network density together with the highest sinuosity is observable during the 1827-1852 period. At this time the Dyje had an anastomosing pattern. The maps from 1876-1883 and 1921-1952 show that in those periods most of the forest water channels had dried out; only a few pools remained. As can be seen in the map, these pools were partly reconnected in the 1950s. Restoration of forest water channels in the 1990s led to an increase in total river network density. Also, new pools were created and some oxbows restored. In 1827-1852, the period of highest sinuosity, this

section of the Dyje had a meandering pattern. Sinuosity decreased at the end of the 19th century to a moderately sinuous pattern. This decrease was caused by natural fluvial processes (meander cut-offs). The map for 1952-1955 once again shows a meandering pattern. River engineering works from the 1970s onward caused a decrease in sinuosity and thus changed the pattern back to a moderately sinuous one.

This section is characterised by stable land use with more than 80% occupied by floodplain forest. This stability can be attributed to several factors: not very favourable hydrological and soil conditions for agriculture; relatively worsened accessibility from settlements; to some extent, its location at the border with Austria (which was closed during the Cold War); but, above all, economic considerations (higher yields from floodplain forests and meadows than from agricultural crops).
