The 1969 Flood and Coastal Erosion on Cape Pitsunda

Olga Yakushenko

Summary

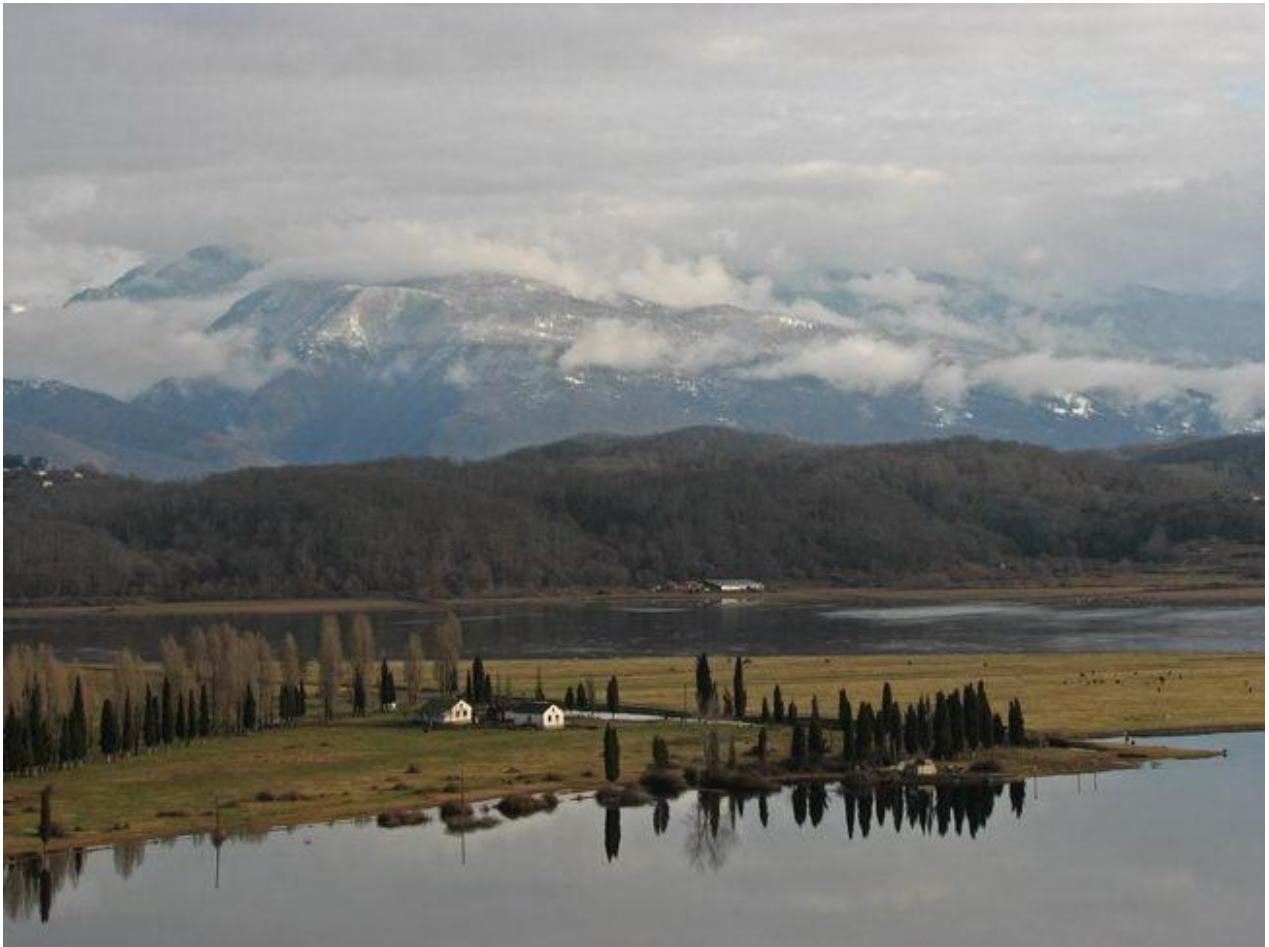
View of Cape Pitsunda after the coastal reconstructions.

The research team then began a closer study of the beach itself. They found that the erosion had exposed the layers of clay at beneath the shingle. These were quickly destroyed once the shingle was gone. They also noticed that the coast on the other side of the river was not only unaffected by erosion, it was even continuing to grow outwards into the water. The cause was found in the mouth of the Bzyb River, which had previously been used for industrial pebble quarrying. After one storm, the river changed course and began to wash away the open-cast mines; one side was therefore reinforced with a concrete wall. As a result, the shingle and sand that made up the beach and protected the coast from erosion washed away only on one side. The clay of the Pitsunda beach slowly lost its protective layer; the storm of 1969 only finished a process that human beings had unknowingly begun. In the 1980s, the Pitsunda beach was reconstructed with the help of specially imported gravel and sand. The long story of the reconstruction shows the destructiveness of unthinking human interference in a complex natural
