## Creating Safety, Courting Disaster on the Lower Shinano River, Japan

Philip C. Brown

Engineering the Lower Shinano River in northeastern Japan to prevent floods such as those of 1896 ironically contributed to increased loss of property and expanded risk of other flood and tsunami damage as the region developed over the next century.

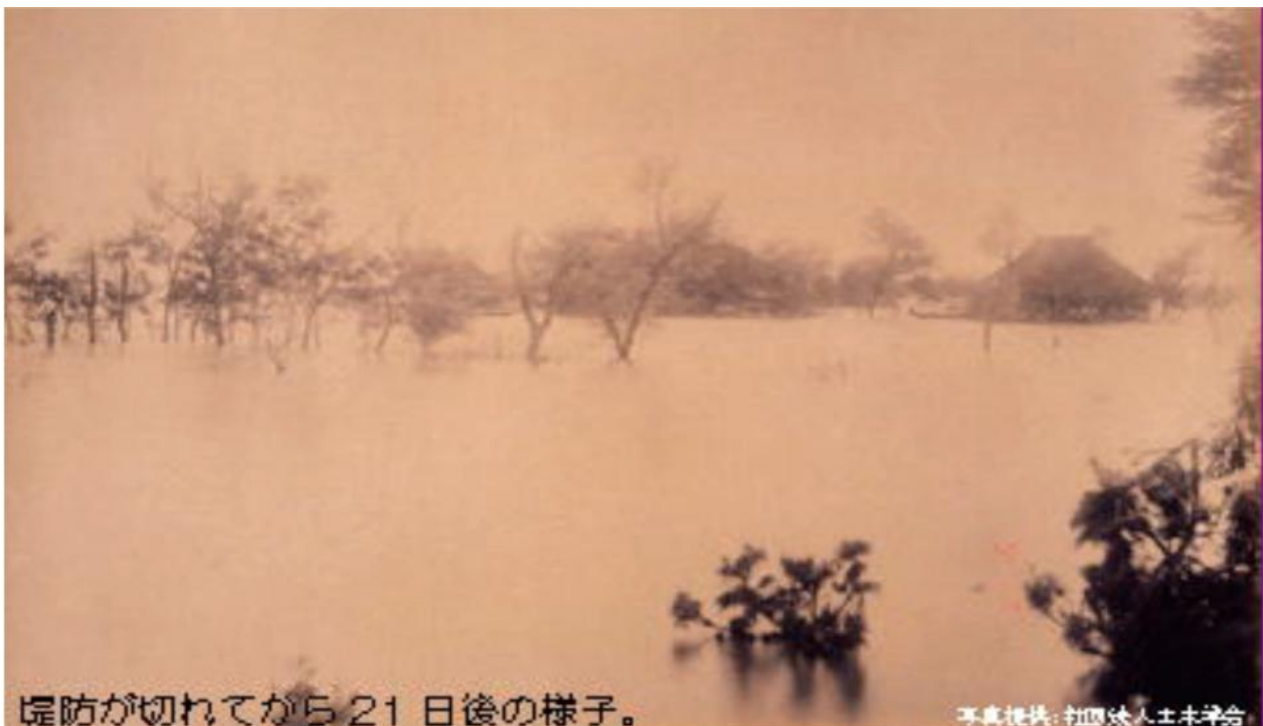
Stagnant floodwaters 21 days after the 1896 flood

On 26 July 1896, after days of rain, the waters of the Shinano River broke through the dikes at Yokota village (southwest of Niigata City) on the Echigo Plain, causing massive flooding. Stagnant water soaked the land for weeks. That event sparked the construction of an overflow channel first proposed in the 1730s, the Okotsu Diversion Channel (Okotsu Bunsui). Today many residents regard it so highly that they have proposed nominating the entire Echigo Plain as a UN cultural heritage site.

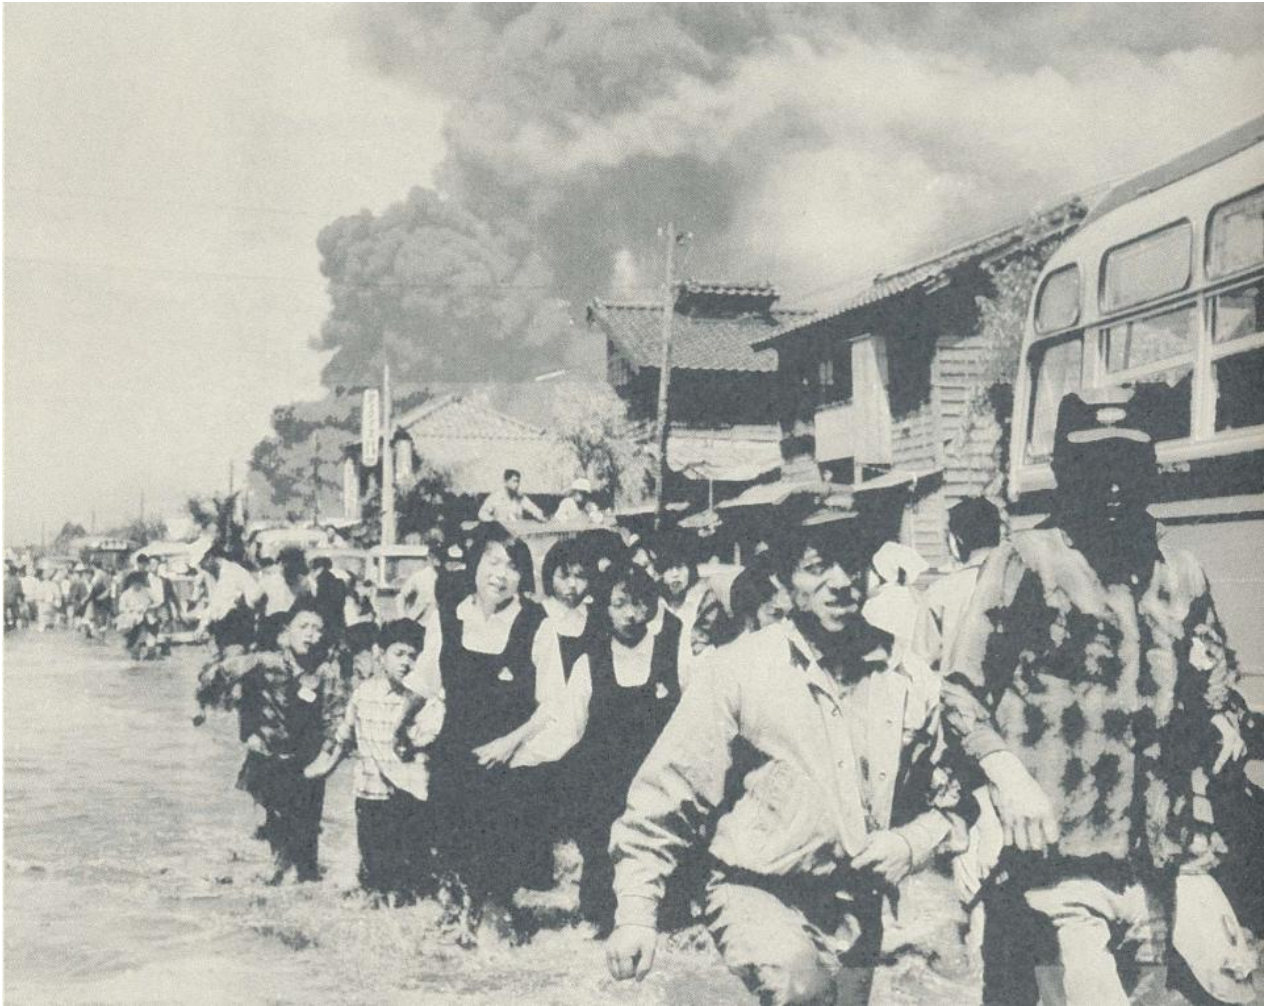
Tsunami-inundated Niigata City, 1964. This image was provided by *Niigata Nippo Sha*.

Further, residents of this area are subject to a special flood risk, from tsunami events, the impact of which is aggravated by subsidence linked to investments in newly identified safe areas. The tsunami caused by the 1964 earthquake surged far into the city. The waters did not drain for several weeks. With increased subsidence, more areas of the city will be at risk for inundation.
