## Creating Safety, Courting Disaster on the Lower Shinano River, Japan

### Summary

Engineering the Lower Shinano River in northeastern Japan to prevent floods such as those of 1896 ironically contributed to increased loss of property and expanded risk of other flood and tsunami damage as the region developed over the next century.

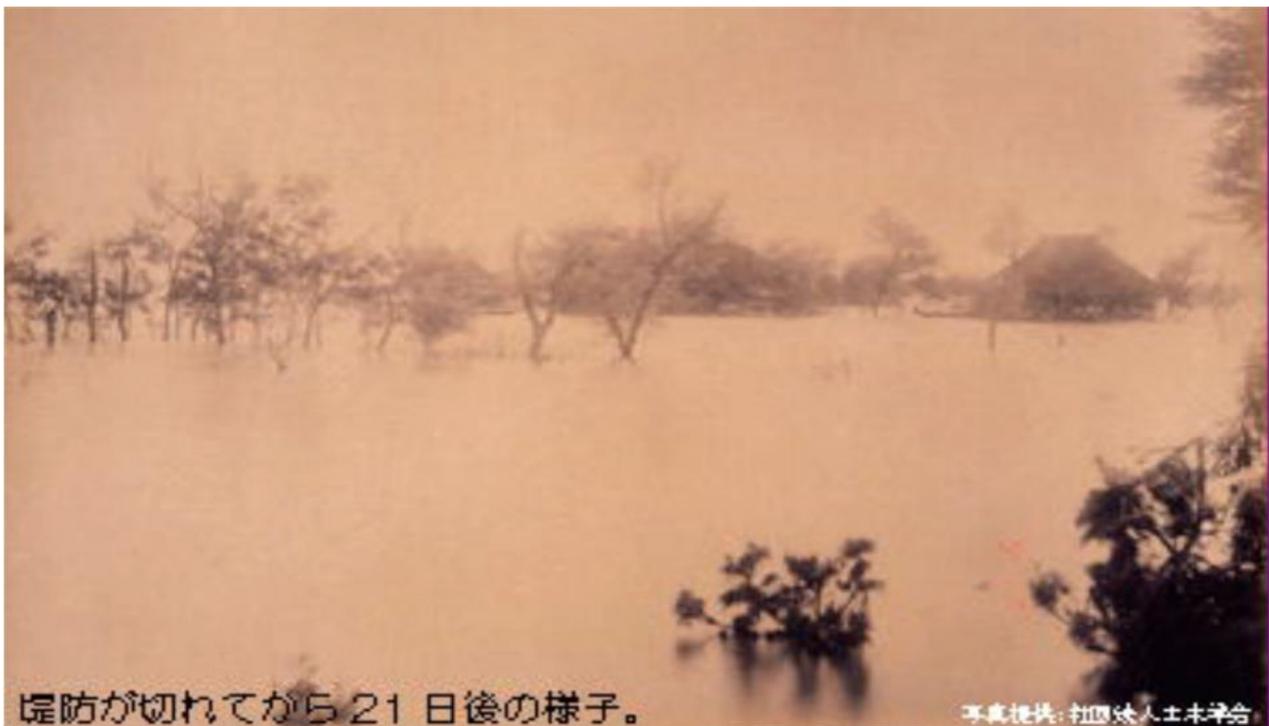
Stagnant floodwaters 21 days after the 1896 flood

On 26 July 1896, after days of rain, the waters of the Shinano River broke through the dikes at Yokota village (southwest of Niigata City) on the Echigo Plain, causing massive flooding. Stagnant water soaked the land for weeks. That event sparked the construction of an overflow channel first proposed in the 1730s, the Okotsu Diversion Channel (Okotsu Bunsui). Today many residents regard it so highly that they have proposed nominating the entire Echigo Plain as a UN cultural heritage site.

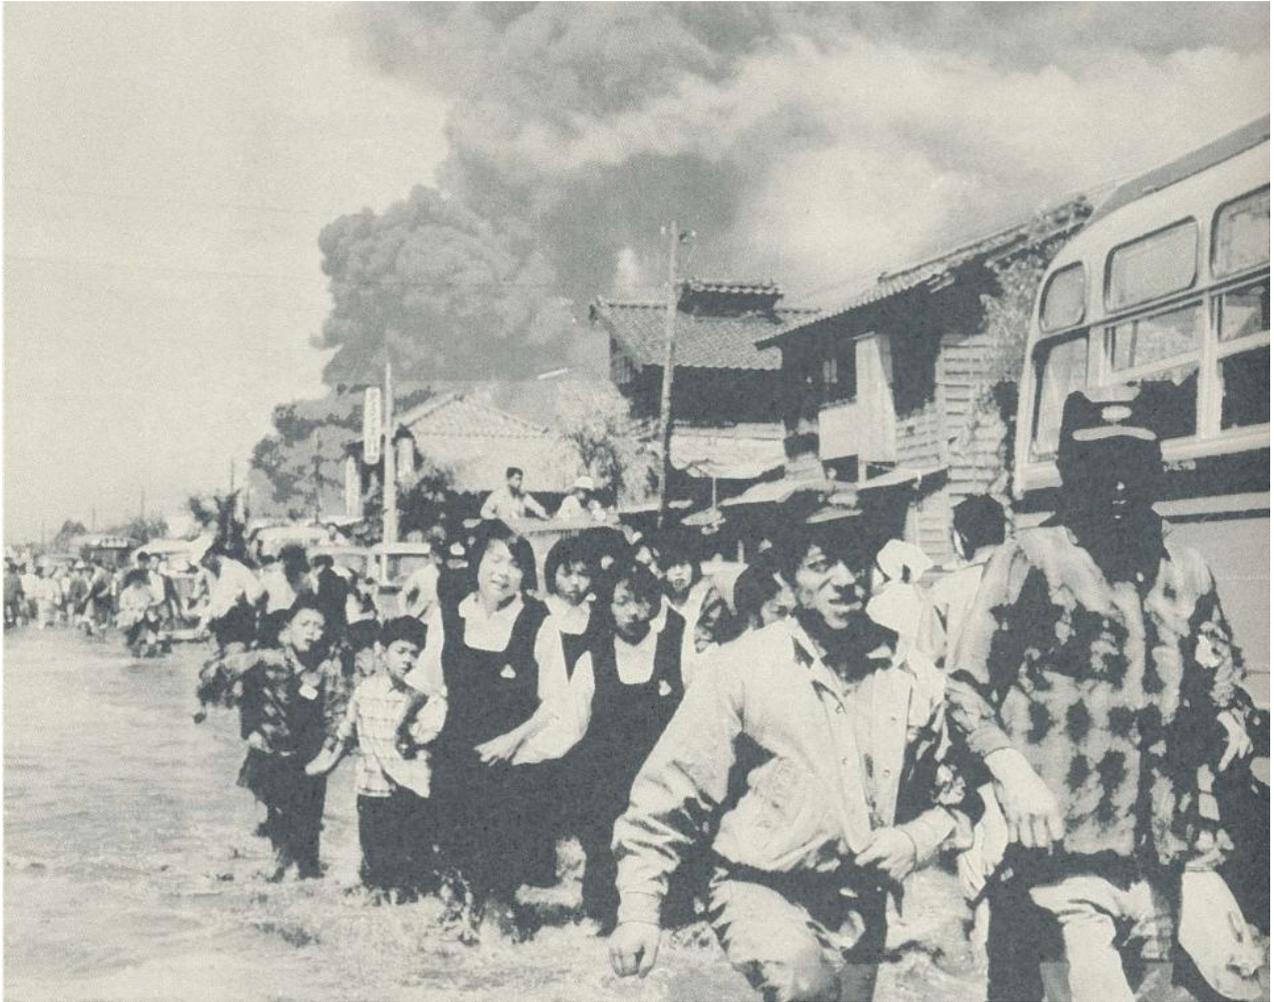
Tsunami-inundated Niigata City, 1964. This image was provided by *Niigata Nippo Sha*.

Further, residents of this area are subject to a special flood risk, from tsunami events, the impact of which is aggravated by subsidence linked to investments in newly identified safe areas. The tsunami caused by the 1964 earthquake surged far into the city. The waters did not drain for several weeks. With increased subsidence, more areas of the city will be at risk for inundation.
