Creating Safety, Courting Disaster on the Lower Shinano River, Japan

Philip C. Brown

Summary

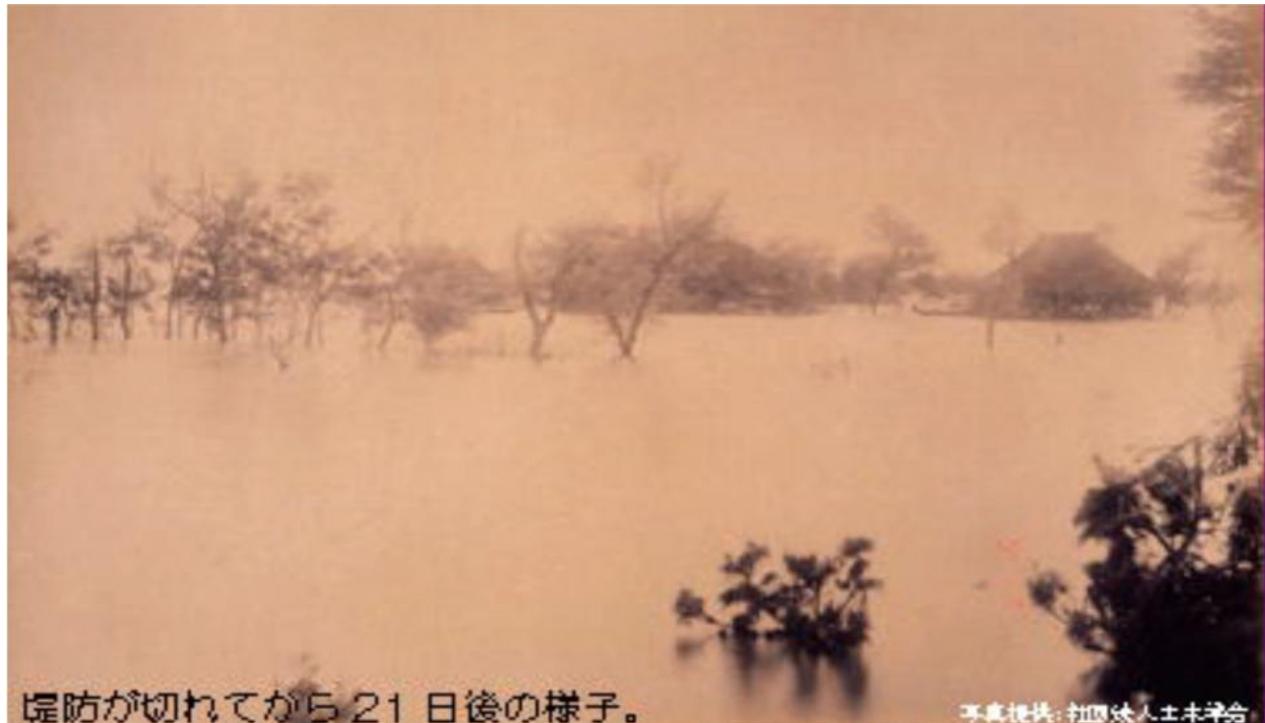
Stagnant floodwaters 21 days after the 1896 flood

On 26 July 1896, after days of rain, the waters of the Shinano River broke through the dikes at Yokota village (southwest of Niigata City) on the Echigo Plain, causing massive flooding. Stagnant water soaked the land for weeks. That event sparked the construction of an overflow channel first proposed in the 1730s, the Okotsu Diversion Channel (Okotsu Bunsui). Today many residents regard it so highly that they have proposed nominating the entire Echigo Plain as a UN cultural heritage site.

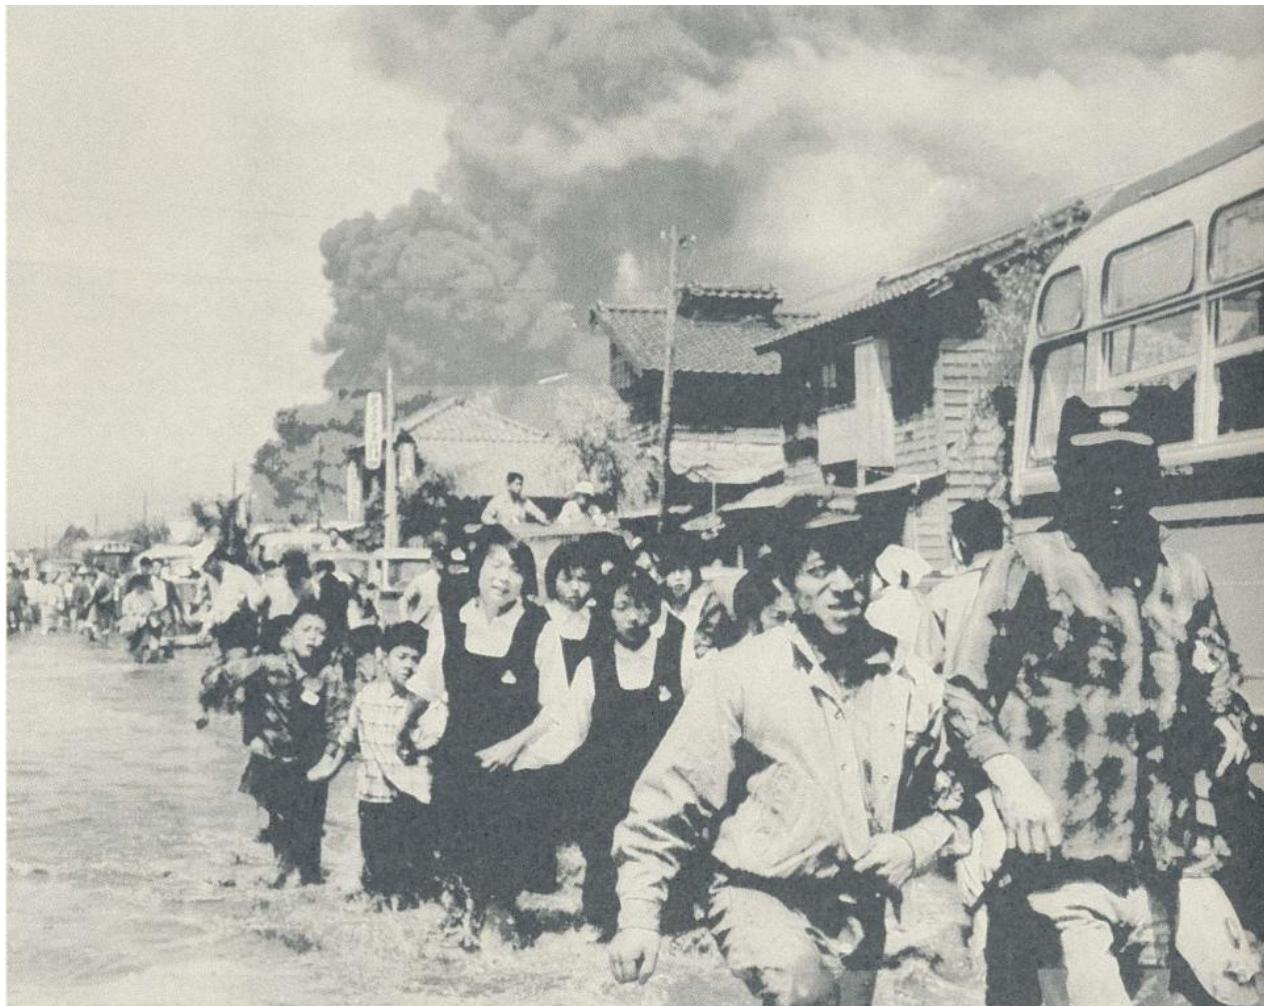
Tsunami-inundated Niigata City, 1964. This image was provided by *Niigata Nippo Sha*.

Further, residents of this area are subject to a special flood risk, from tsunami events, the impact of which is aggravated by subsidence linked to investments in newly identified safe areas. The tsunami caused by the 1964 earthquake surged far into the city. The waters did not drain for several weeks. With increased subsidence, more areas of the city will be at risk for inundation.
