# Creating Safety, Courting Disaster on the Lower Shinano River, Japan

Philip C. Brown

# Summary

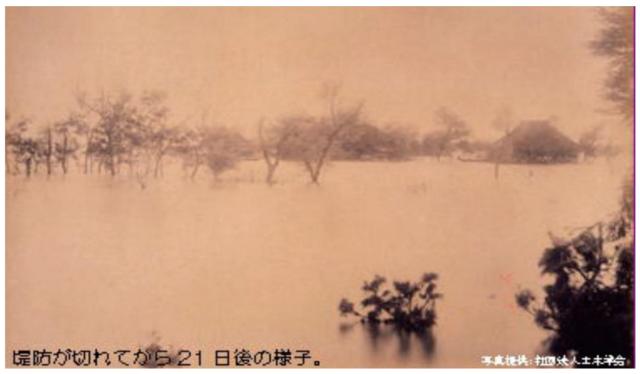
Stagnant floodwaters 21 days after the 1896 flood

On 26 July 1896, after days of rain, the waters of the Shinano River broke through the dikes at Yokota village (southwest of Niigata City) on the Echigo Plain, causing massive flooding. Stagnant water soaked the land for weeks. That event sparked the construction of an overflow channel first proposed in the 1730s, the Okotsu Diversion Channel (Okotsu Bunsui). Today many residents regard it so highly that they have proposed nominating the entire Echigo Plain as a UN cultural heritage site.

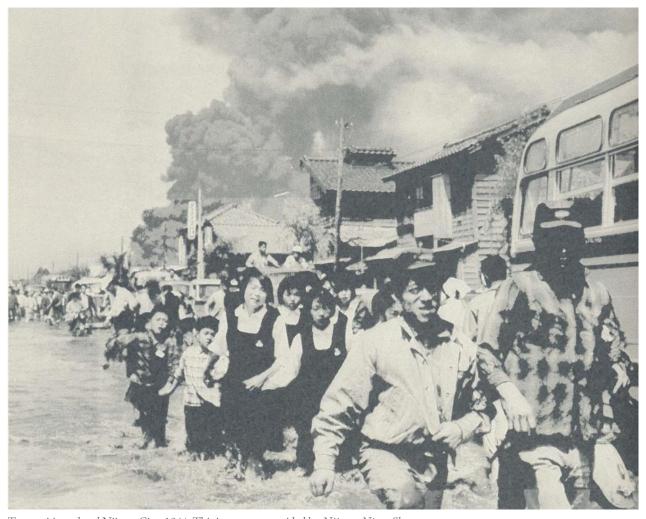
Tsunami-inundated Niigata City, 1964. This image was provided by Niigata Nippo Sha.

Further, residents of this area are subject to a special flood risk, from tsunami events, the impact of which is aggravated by subsidence linked to investments in newly identified safe areas. The tsunami caused by the 1964 earthquake surged far into the city. The waters did not drain for several weeks. With increased subsidence, more areas of the city will be at risk for inundation.
