## From Pulley to Pipe: The Decline of the Wells of Bangalore

Harini Nagendra and Hita Unnikrishnan

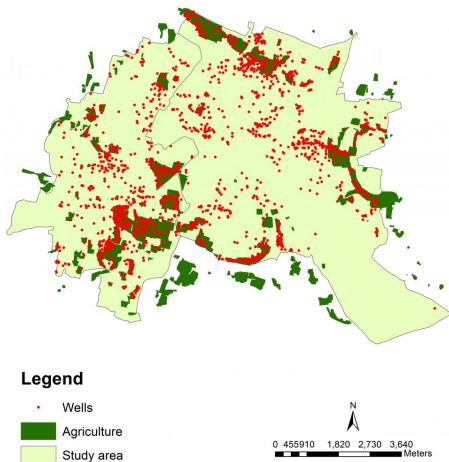
Presence and distribution of wells in the city of Bangalore, circa 1885

By 1935, Bangalore had expanded substantially, and agriculture within the city had declined. The number of wells had dropped from 1,960 in 1885, to just 490 in 1935. Reflective of larger trends of urbanization, cultivated areas were concentrated at the periphery of the native city and the Cantonment (the two jurisdictional divisions of colonial Bangalore), with wells mostly located close to areas of cultivation. By 1973, only 149 wells were recorded, largely at the periphery of the city where urban pressures were lower, and agricultural practices still extant. Wells were still important sources of water but only when associated with a use such as agriculture that was water intensive, and whose needs could not be met by piped water supply.

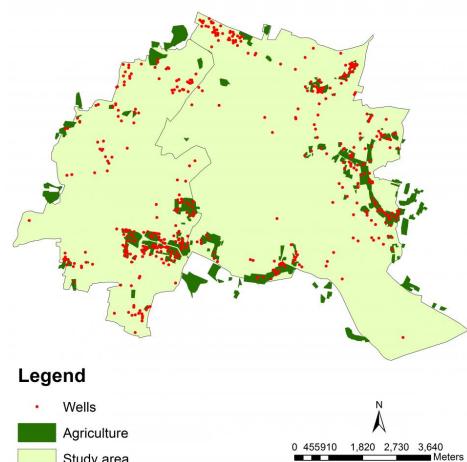
Presence and distribution of wells in the city of Bangalore, circa 1935
