## How a Catastrophic Flood of the Gürbe River Triggered the Rethinking of Local Flood Protection

Melanie Salvisberg

### Summary

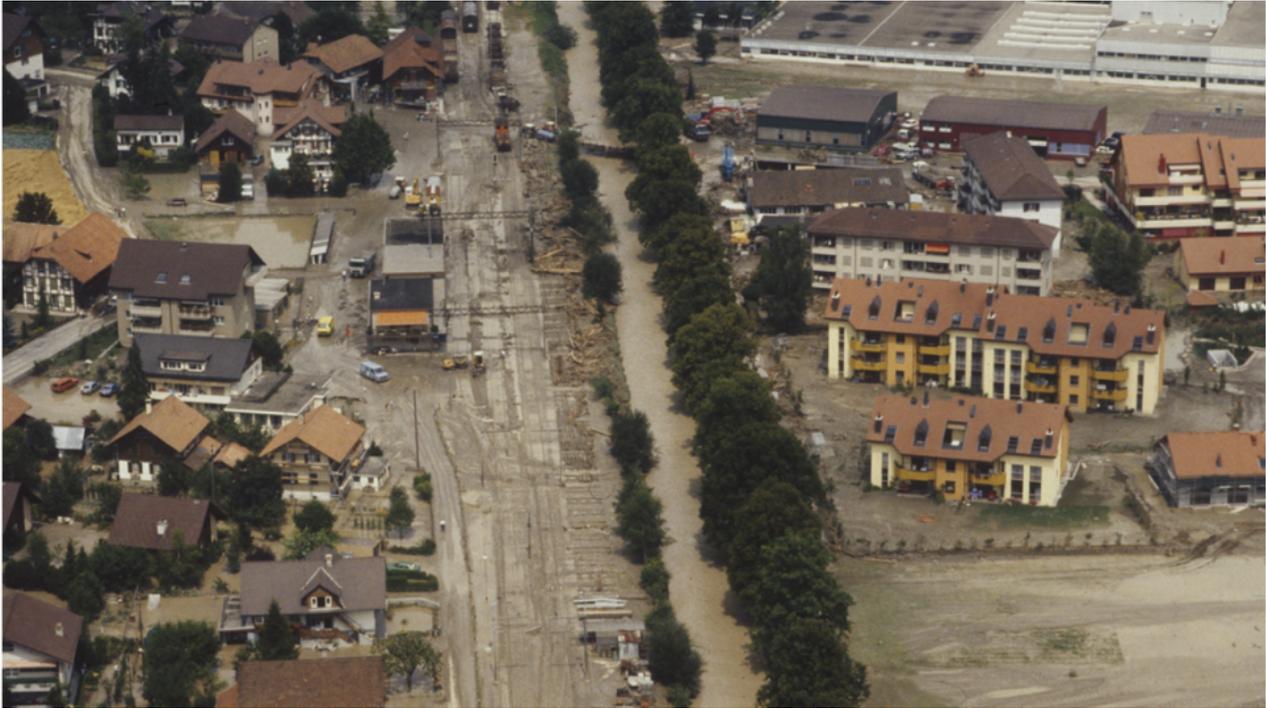
Flooded settlement in Toffen after the event of 29 July 1990.

On the evening of 29 July 1990, after a warm and sunny day, the sky over the Gantrisch region in the Swiss pre-Alps suddenly darkened. A huge thunderstorm appeared—a thunderstorm that not only set a meteorological record, but also changed the approach to flood protection in the Gürbe River area profoundly. Within a short period, the water level rose rapidly, causing the 29-kilometer-long river, a tributary that joins the Aare River south of Bern, to overflow. The water and the bed load caused severe damage to hydraulic structures, farmland, settlements, and traffic facilities near the river. The total cost of the damage was estimated to be 40 million Swiss francs.

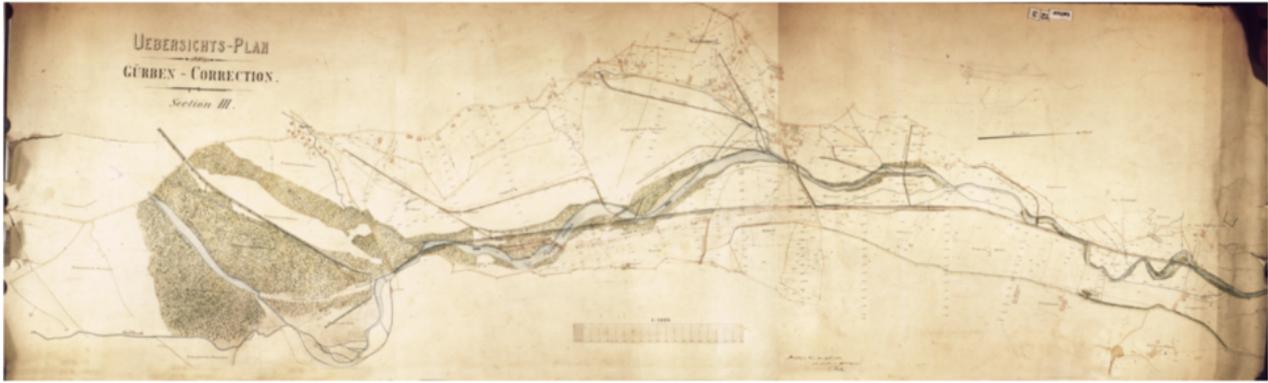
Plan of the natural course of the Gürbe River and the planned channel in Wattenwil, 1881.

Although the Gürbe Valley was known to be flood-prone, due to frequent thunderstorms, steep slopes, soil with low water-storage capacity, and soft rock in the upper reaches, the extent of the event was a shock, especially because extensive measures had been taken to prevent inundations since the mid-nineteenth century. The efforts had started with alterations to the Gürbe River from 1855 to 1881. With the intent of protecting the Gürbe Valley from flooding but also of reclaiming new land from the swampy flood plain, the previously meandering river was straightened and channelized in its flat lower course. In the steep upper reaches, numerous workers erected dozens of wooden and stone dams to control discharge and sediment transport. Dikes to deflect the flow of debris, drainage systems, and slope stabilizations completed the torrent control.

Although the measures ameliorated the flooding situation, the goal of completely preventing inundations was not achieved. Again and again, landslides and floods led to damage. The hydraulic structures were therefore renewed and expanded in numerous consecutive projects. The main focus lay on the upper reaches, where the workers built larger and additional transverse structures (made from concrete since the early 1900s) and completed the slope stabilizations. Similar structures were built in the tributaries. On the valley floor, the channel was extended and widened. In addition to the hydraulic structures, hundreds of hectares of alpine meadow were reforested in the river's catchment area, despite resistance from landowners. In the beginning of the twentieth century, the Gürbe River was embanked and consolidated from its mouth to its source.

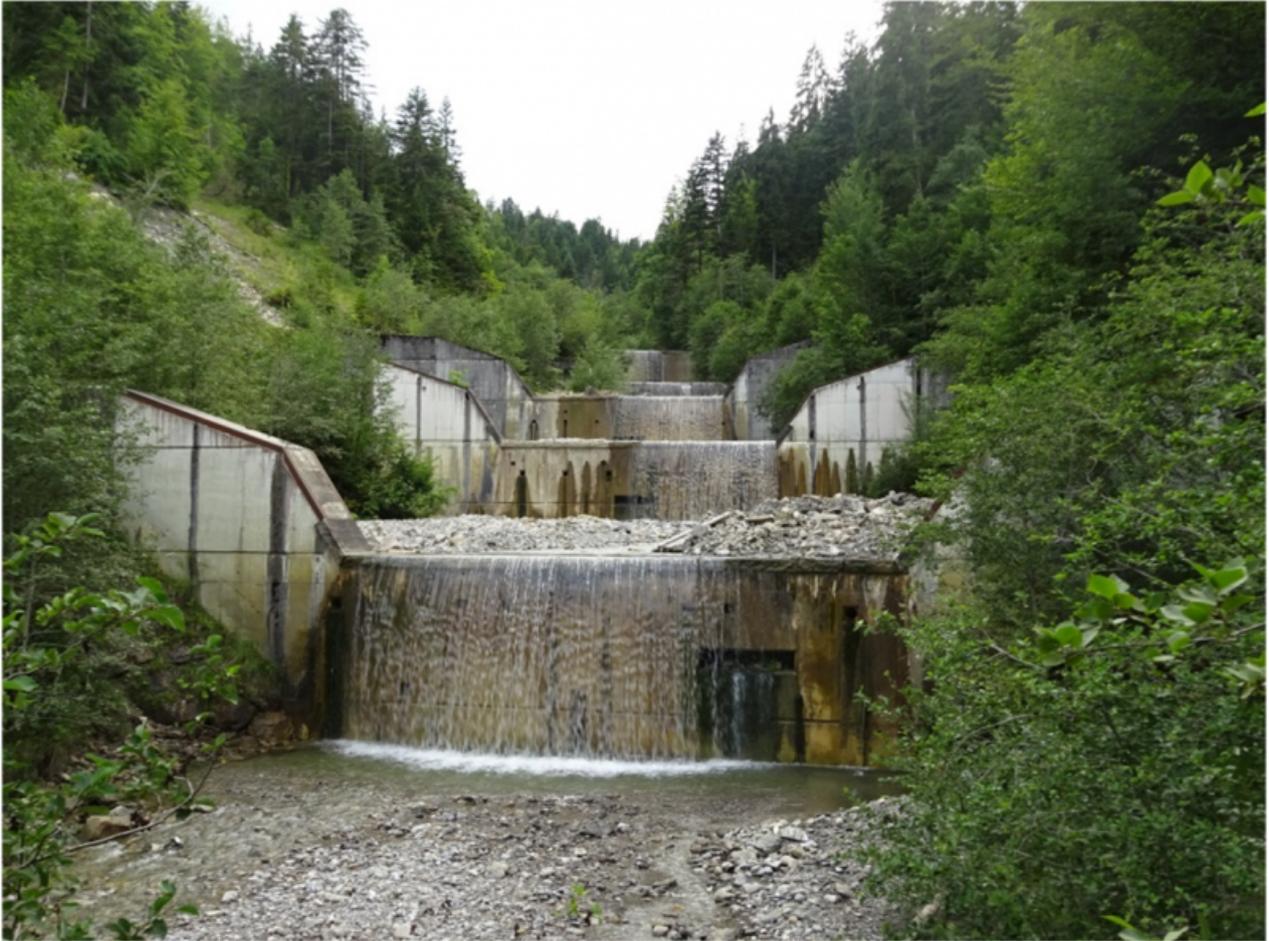
Torrent check dams in the gorge of the Gürbe River.

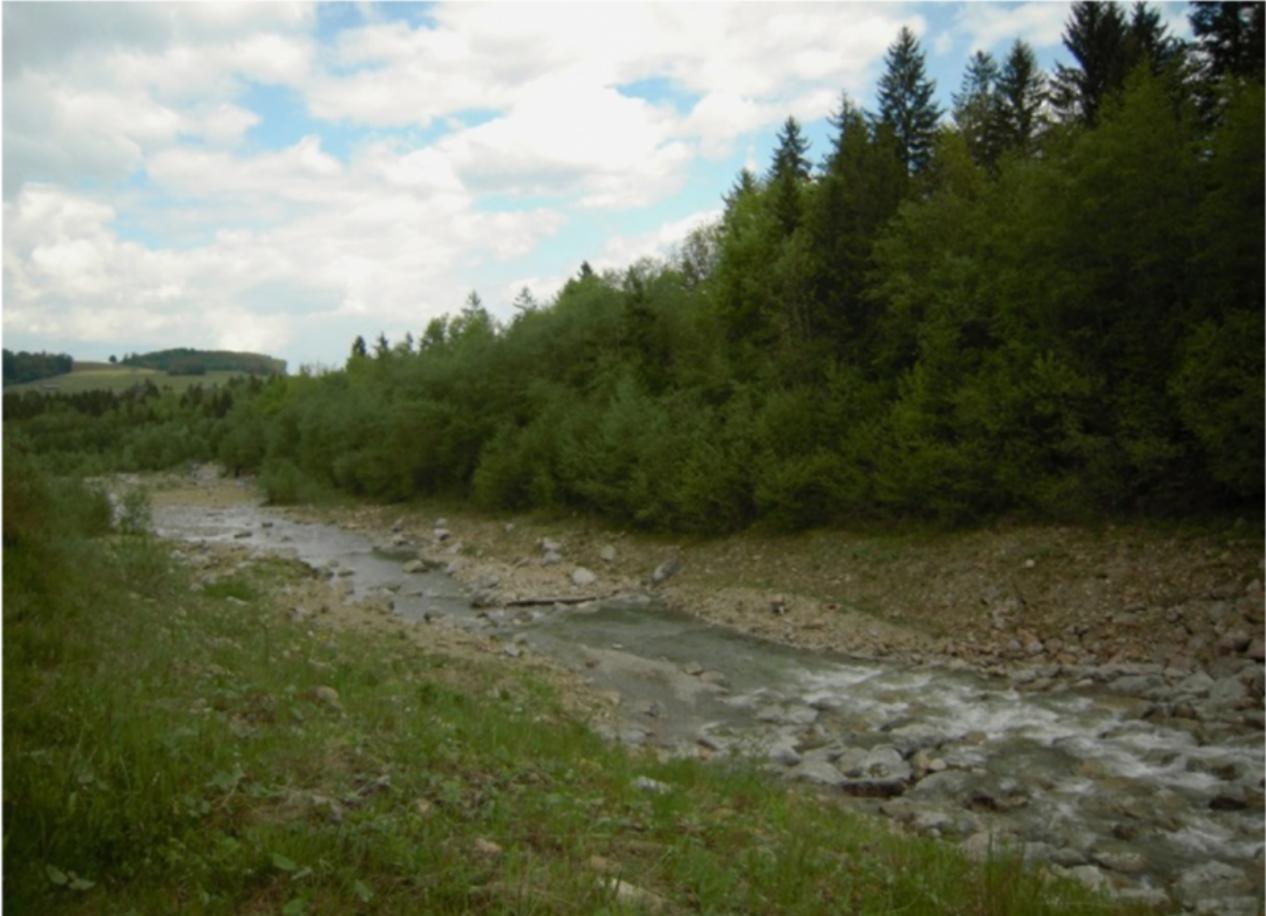
Partly restored stretch of the Gürbe River on the alluvial fan today.

As with many other Swiss rivers, the renaturation of the Gürbe River was only partially feasible due to the intense use of the riverine zone. Larger revitalized stretches could, however, be developed in the area of the river mouth and on the alluvial fan. For the valley floor, the hydraulic engineers planned retention areas.
